INSPECTION REPORT

Project	Pipe Inspection	Notification No.	N/A
PO No.	CIK-IR-Cangzhou-Abert-Pipe-20250920	Report No.	N/A

Vendor/Location	HEBEI ABTER STEEL PIPE CO., LTD.	Person Contracted	Mr. Huang Dong
Sub-vendor/Loc.		Inspection Date	20 th Sep 2025
Delivery Date	N/A	Next Inspection Date	N/A

➤ As per PO and client requirements, the CHITAKO inspector arrived at the Cangzhou Haihao Huizhe Steel Pipe Co., Ltd. to perform the final inspection for pipes on Sept. 20th 2025.

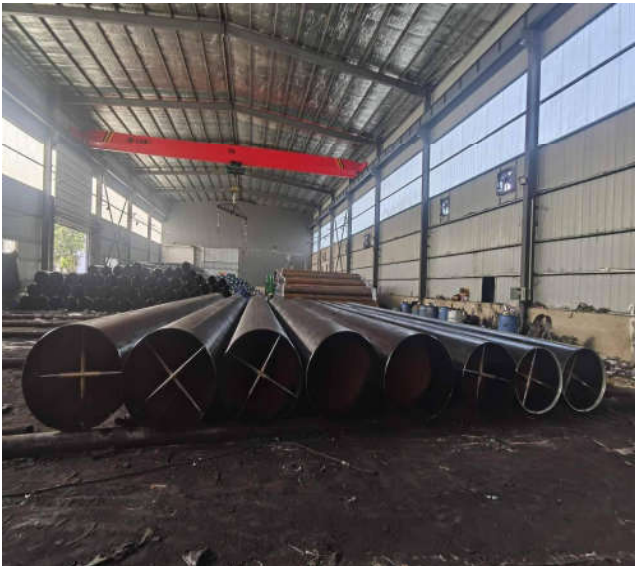
Quantity inspection

- Per the PO, the inspector checked the quantity of steel pipes and found the quantity was met the PO requirement.
- The result was acceptable.

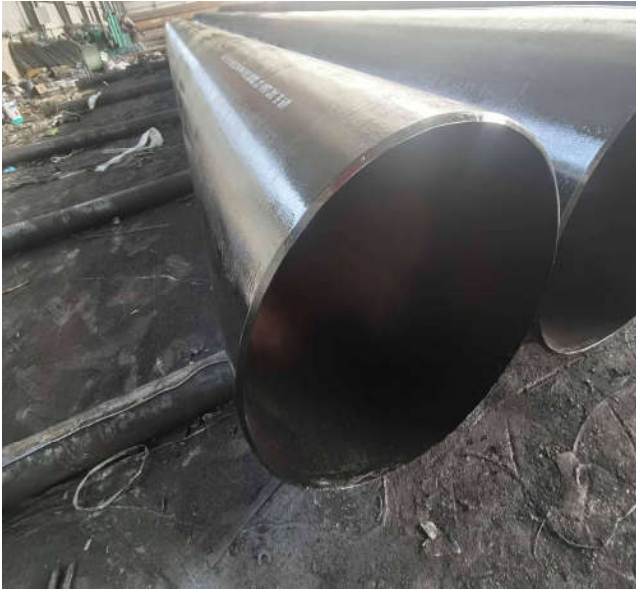
Visual inspection

- As per the client's requirement, the inspector checked the internal and external surface quality of the pipes. No found damage, deformation, etc.
- Inspector checked the quality of the welds on inside and outside of the pipe, no found porosity, spatter, missing welding, pit and undercut.
- Inspector checked the paint and no found bubbling, pin-holes, orange skin, runs etc.
- The result was acceptable.

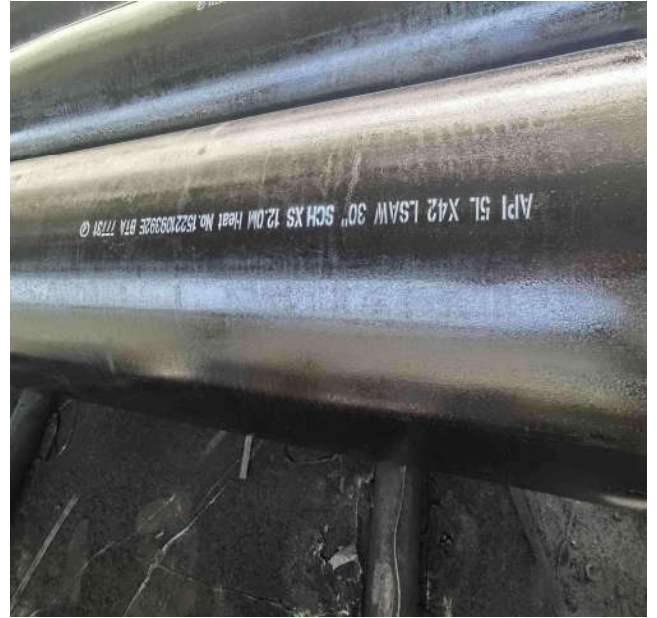
Marking inspection

- As per the client's requirement, the inspector checked the marking of the pipes.
- The inspector found the marking information were correctly and clearly marked on the pipe surface
- The marking inspection results were acceptable.
- Detail as follow:

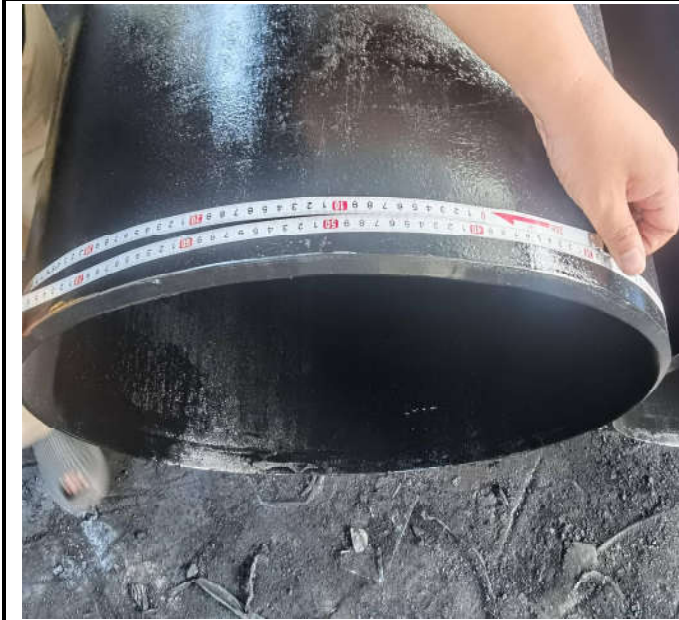
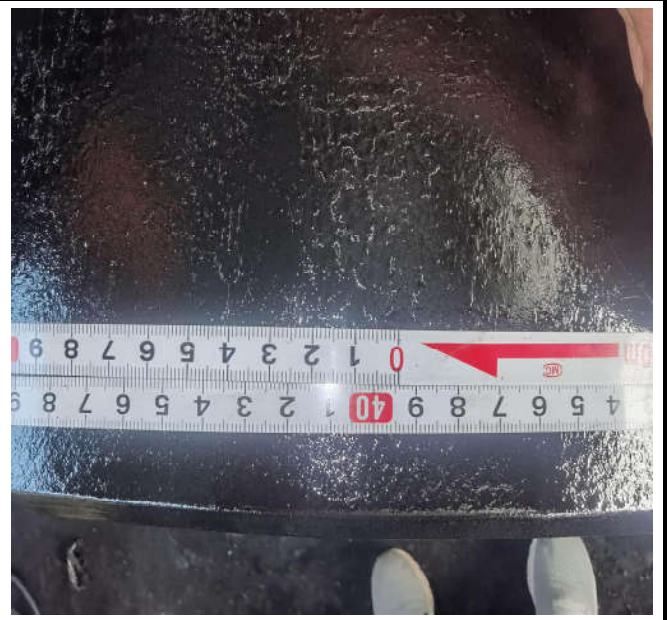
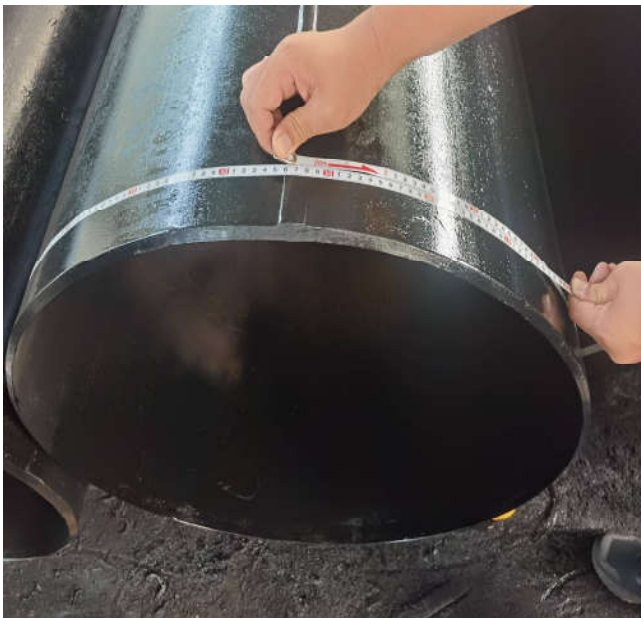
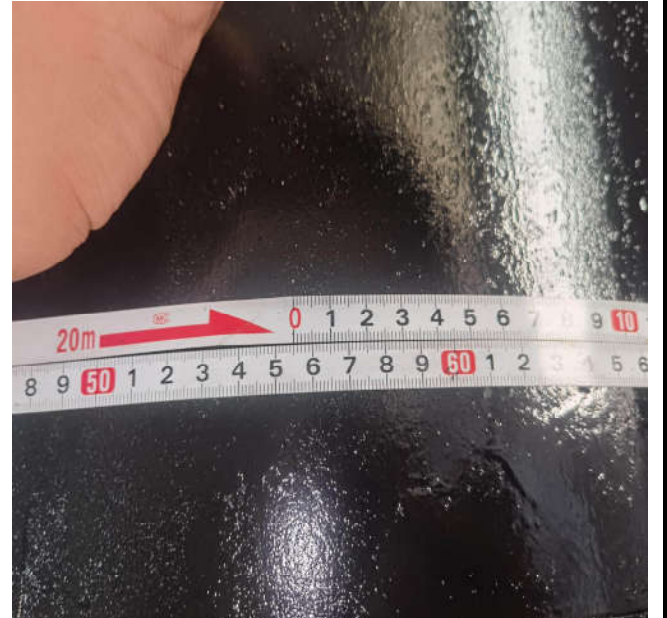
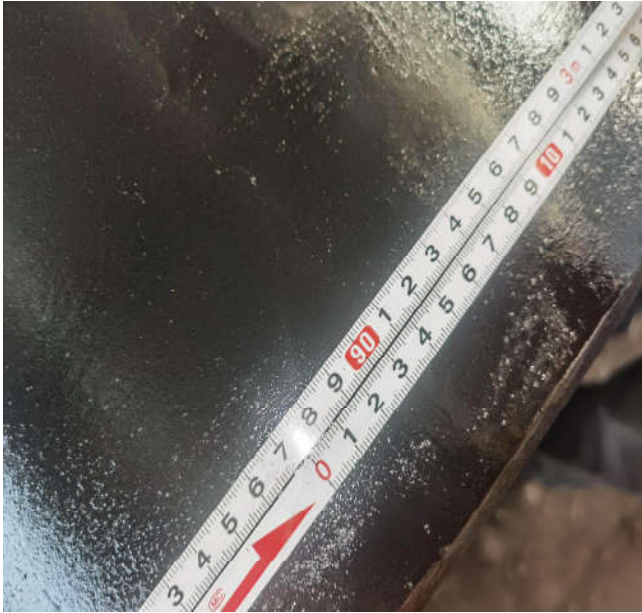
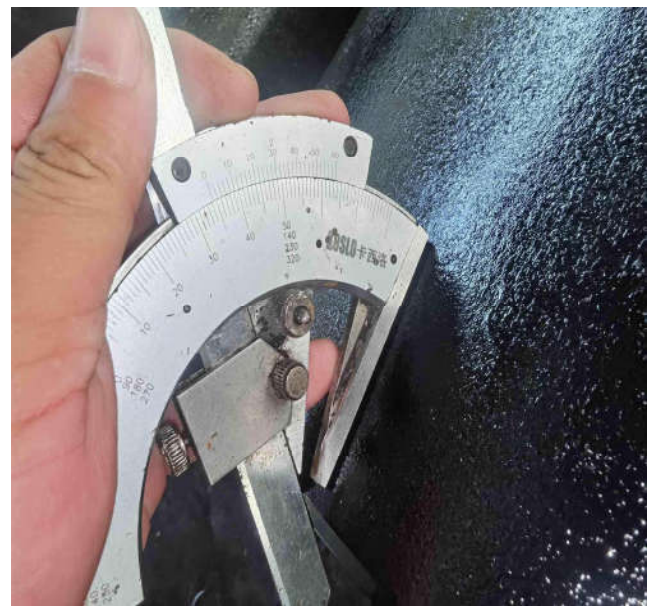
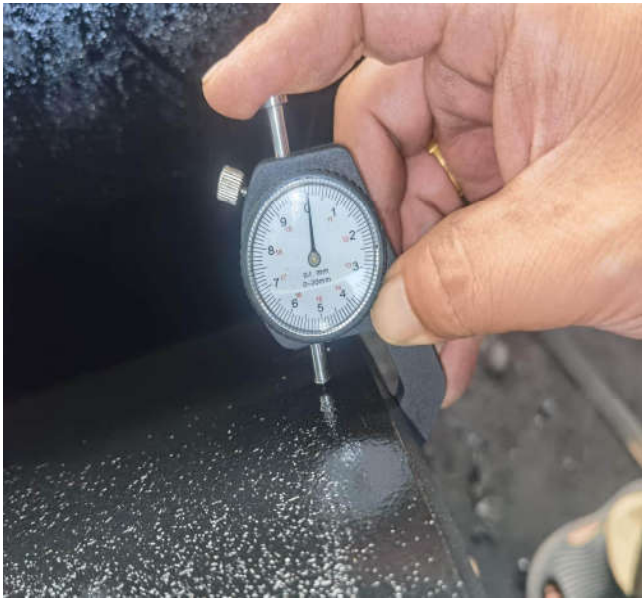
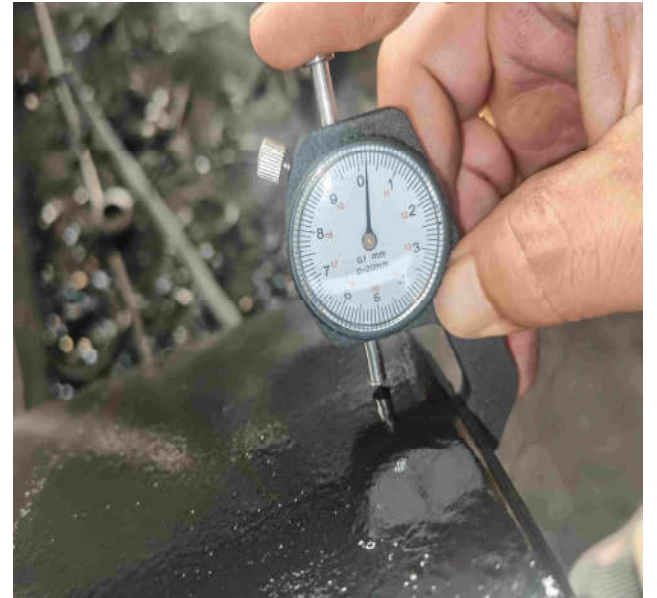
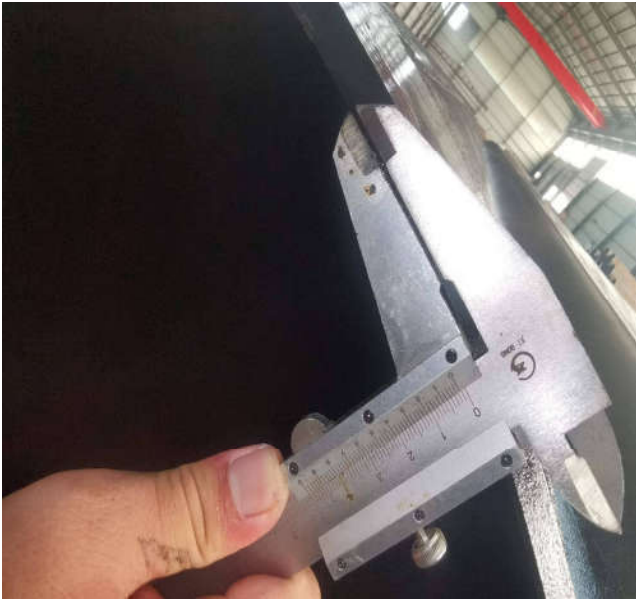
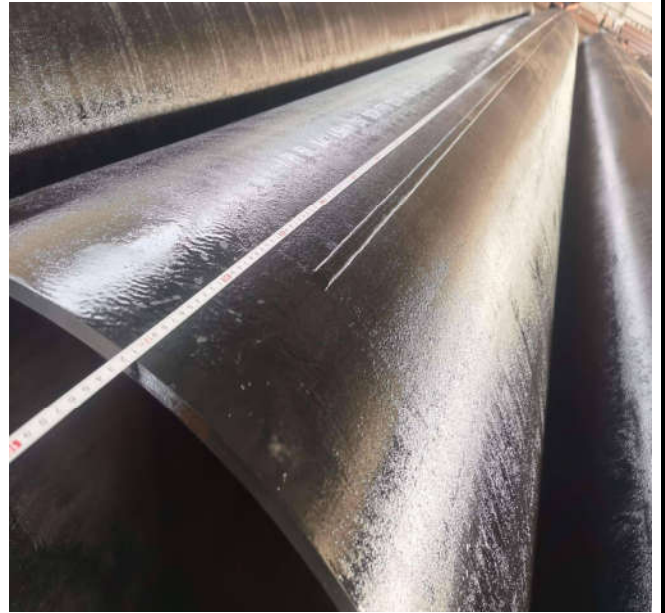
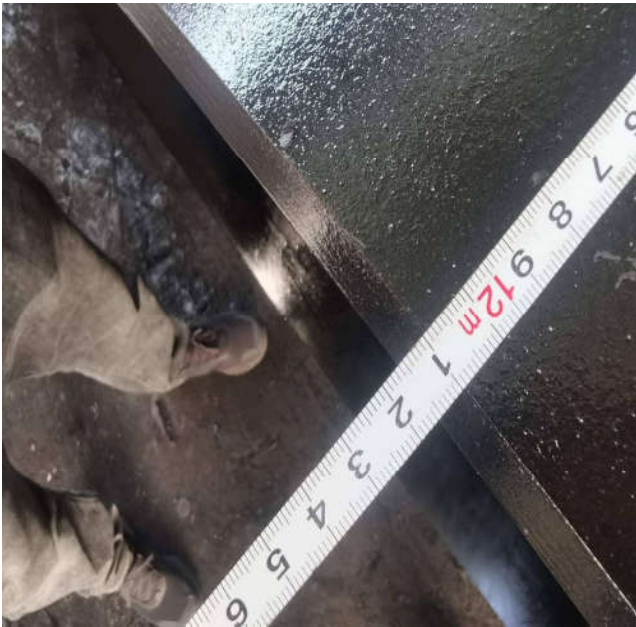
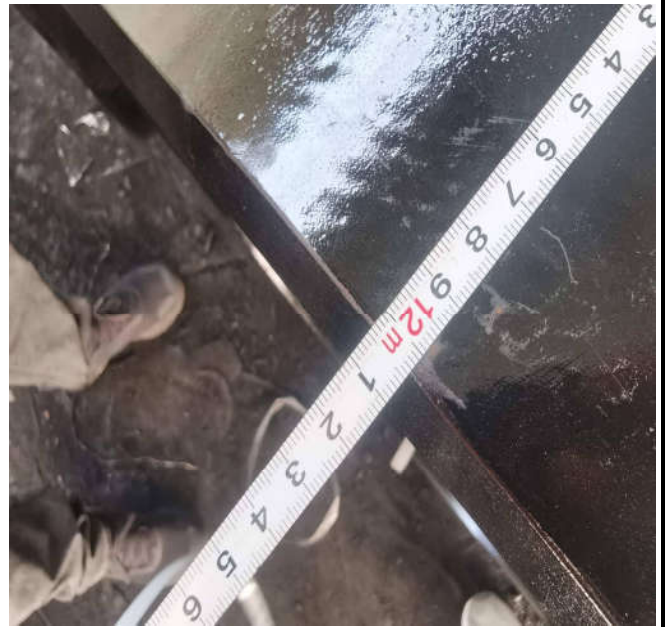
- As per API 5L, the inspector checked the dimension of the pipes.
- Before dimension inspection, all used tools were checked and found in good condition and calibrated & within the validity period.
- The dimension inspection results were acceptable.
- Detail as bellow :

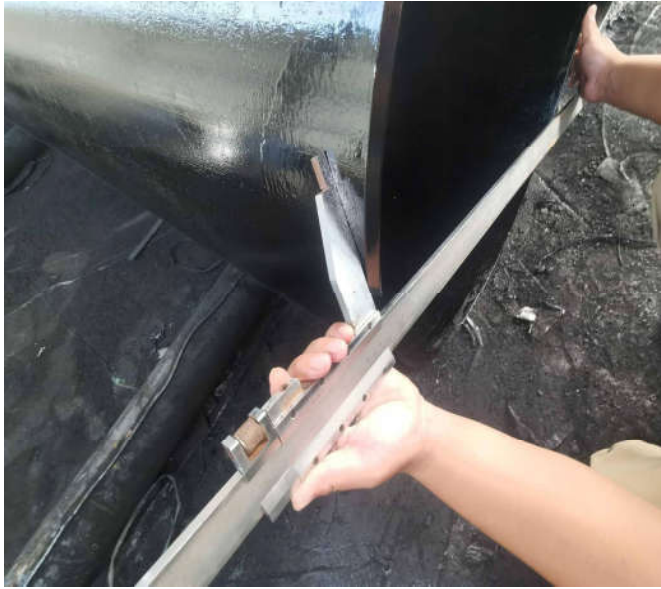
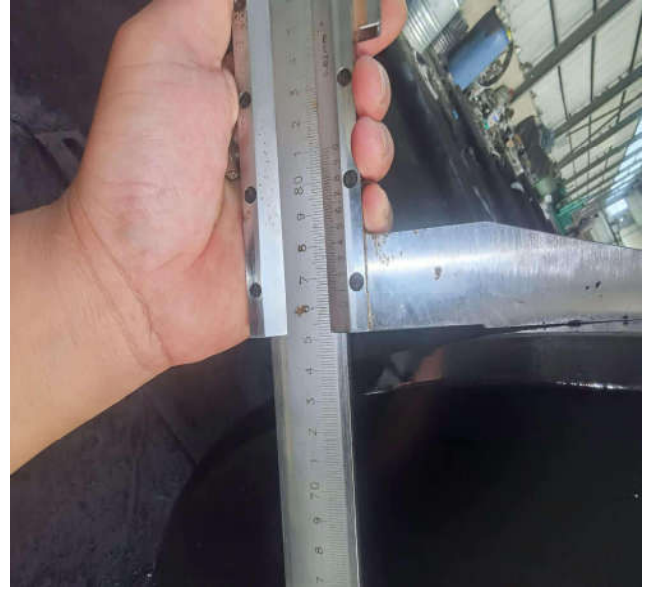
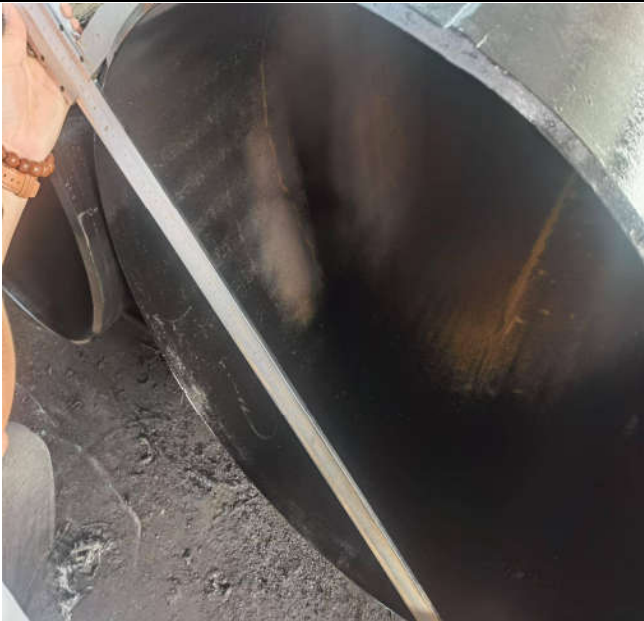
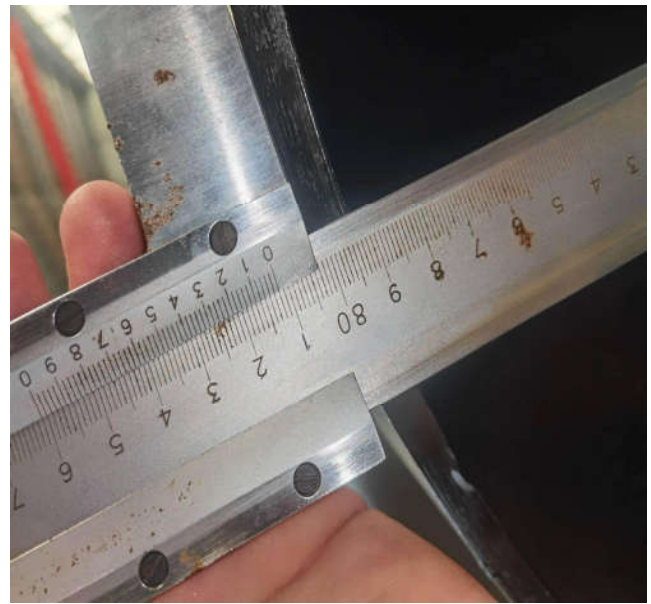
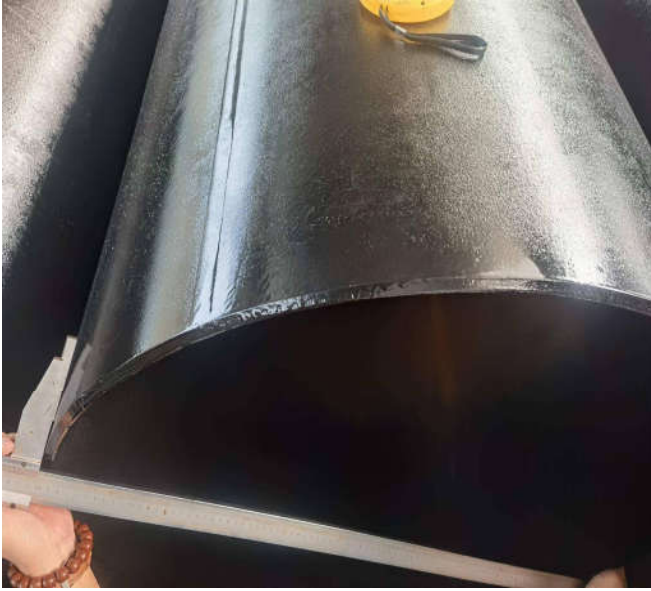
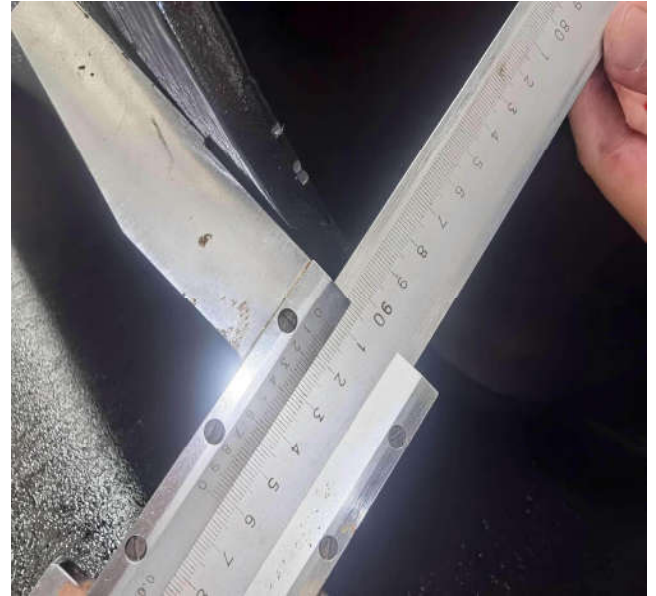
- As per the API 5L, inspector checked the ovality of the pipes. The testing method employs the diameter method.
- The result was acceptable.
- Detail as bellow :(Unit: mm)
