INSPECTION REPORT

Project	Pipe Inspection	Notification No.	N/A
Report No.	CIK-IR-Cangzhou-Abert-Pipe-20251114	PO No.	N/A

Vendor/Location	HEBEI ABTER STEEL PIPE CO., LTD	Person Contracted	Mr. Huang
Sub-vendor/Loc.		Inspection Date	Nov. 14 th 2025
Delivery Date	N/A	Next Inspection Date	N/A

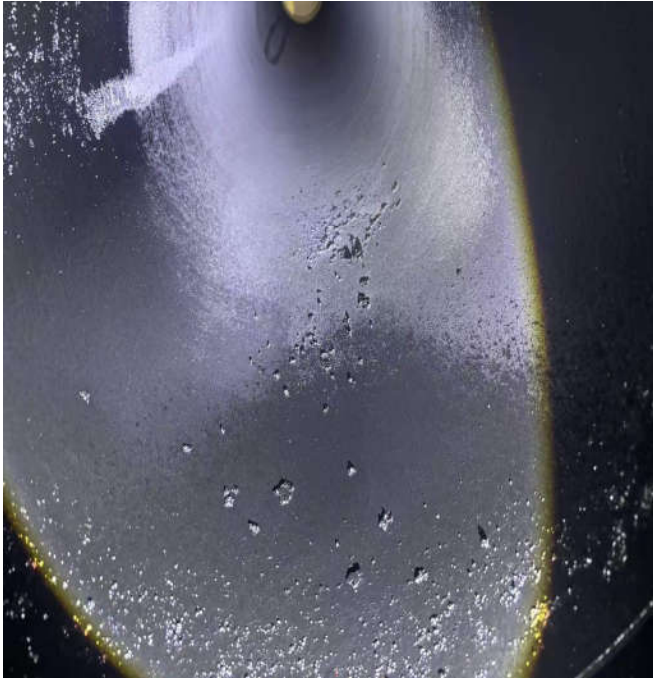
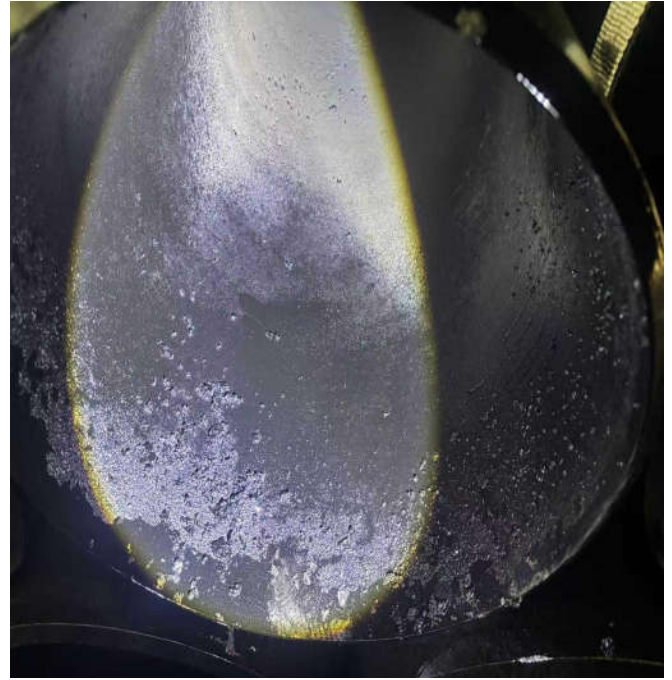
- Comment-01: Some iron filings and debris were found on item 3 pipes inner surface. The iron filings and debris were cleaned up onsite. This punch item was closed by vendor.

Some iron filings and debris

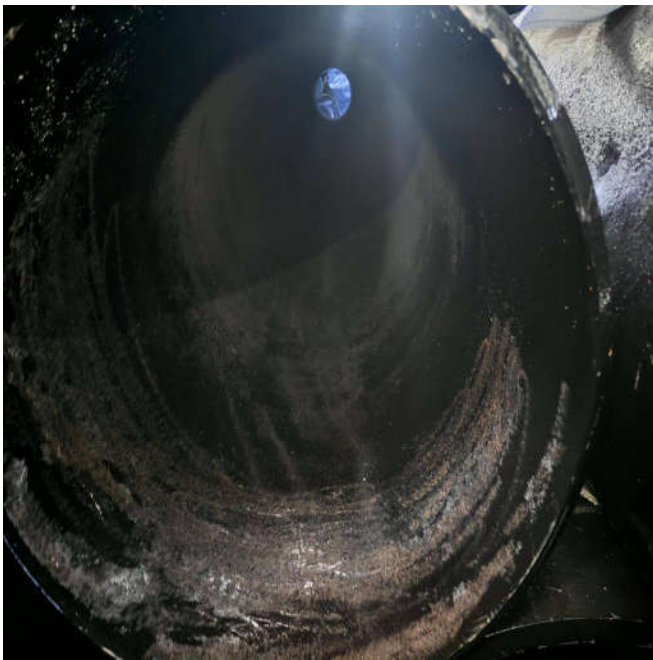
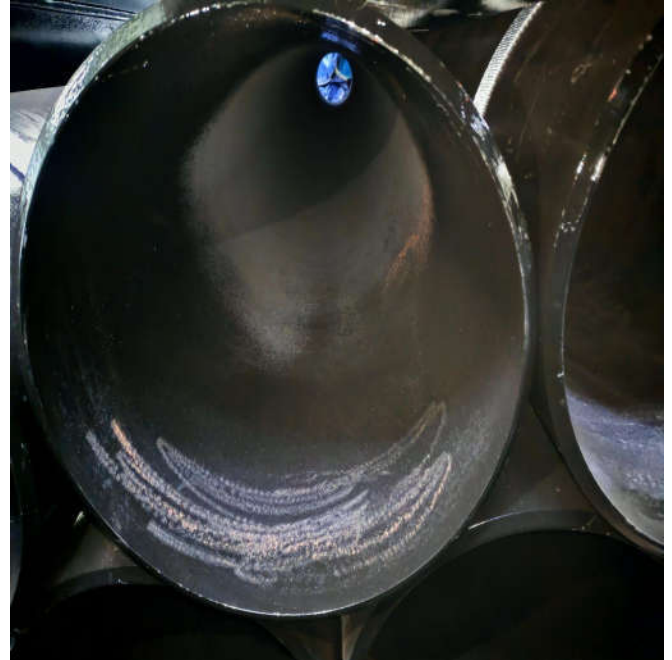
After cleaned up

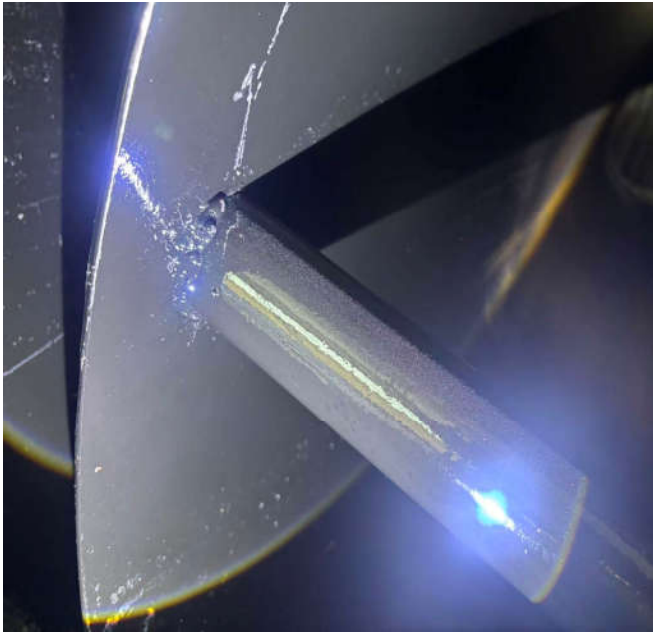
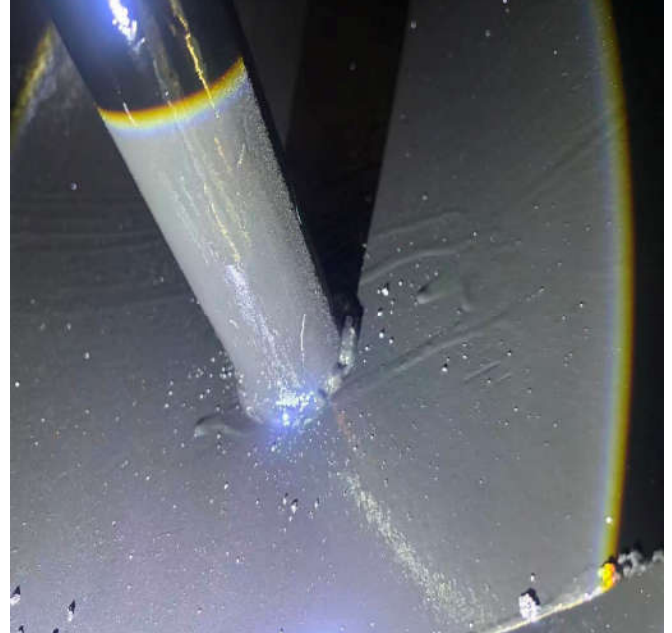
- The iron cross arm was found on item-01 pipe, the iron arms is directly welded to the pipe wall. This punch items need to be confirmed by client. Please note that the welding appearance in the iron crossarm area is very poor, with welding spatter, run-off and residual welding slag.

The iron cross arm was found on item-01 pipe, the iron arms is directly welded to the pipe wall. This punch items need to be confirmed by client. Please note that the welding appearance in the iron crossarm area is very poor, with welding spatter, run-off and residual welding slag.

the iron arms is directly welded to the pipe wall

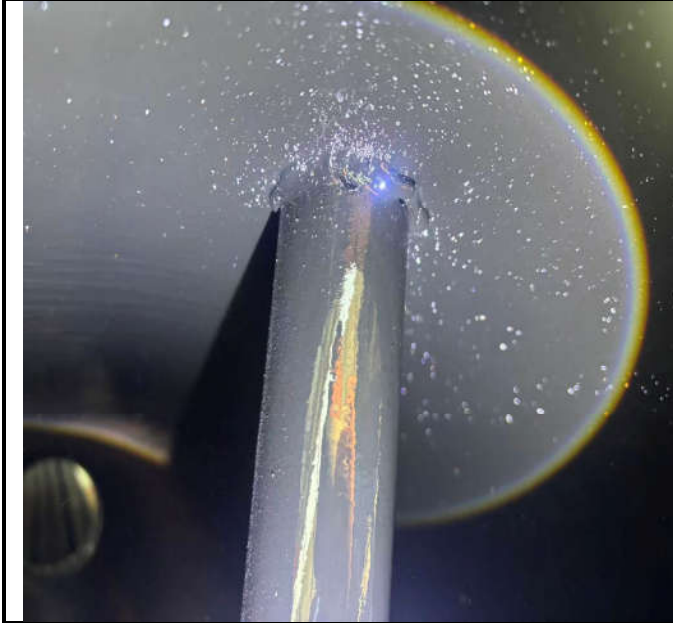
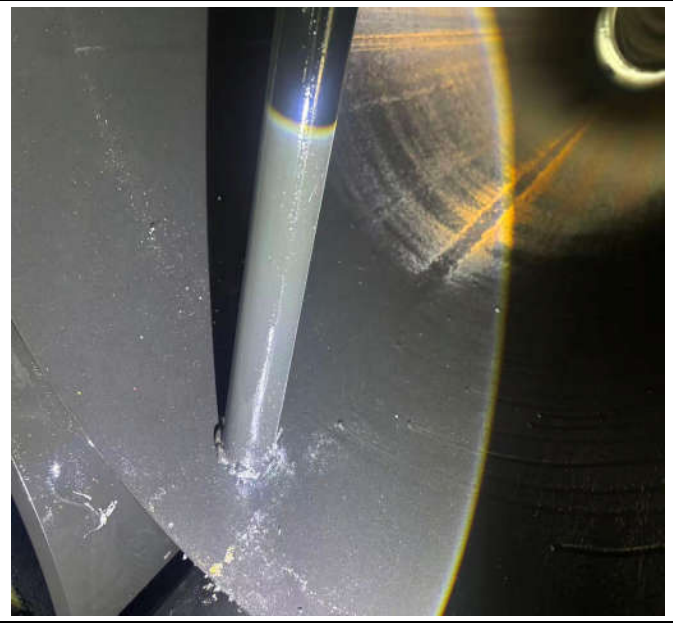
the iron arms is directly welded to the pipe wall
