INSPECTION REPORT

Project	Steel Plate Inspection	Notification No.	N/A
Report No.	CIK-IR-Wuxi-Abert-Steel Plate-20250327	PO No.	N/A

Vendor/Location	HEBEI ABTER STEEL PIPE CO., LTD	Person Contracted	Mr. Wang
Sub-vendor/Loc.		Inspection Date	27-Mar-2025
Delivery Date	N/A	Next Inspection Date	N/A

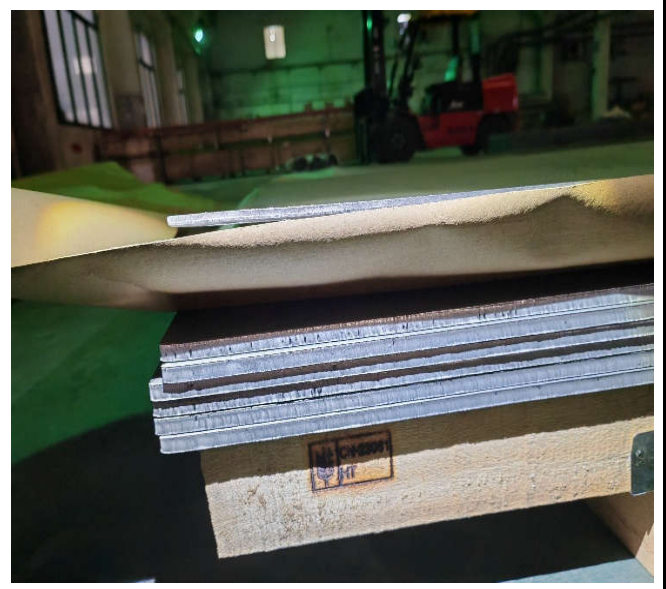
Quantity confirmation

- When the inspector arrived at the site, the quantity of the steel plate was consistent with the PO requirement.
- The quantity inspection result was acceptable.
- Details as below:

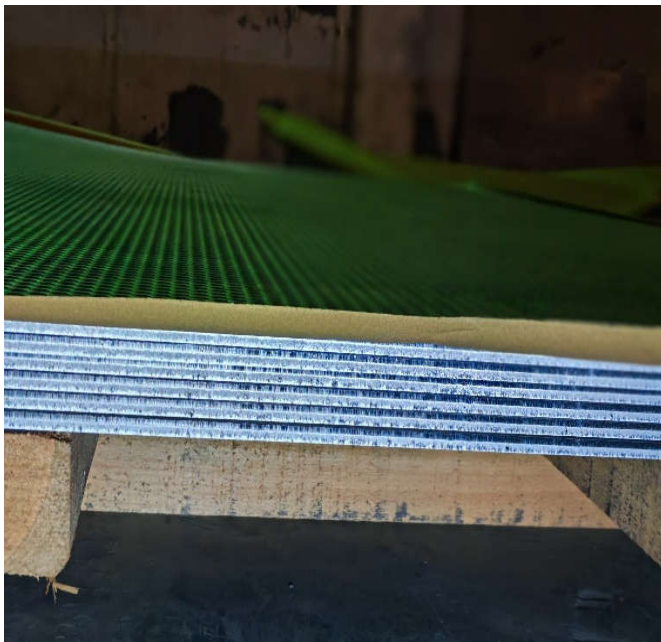
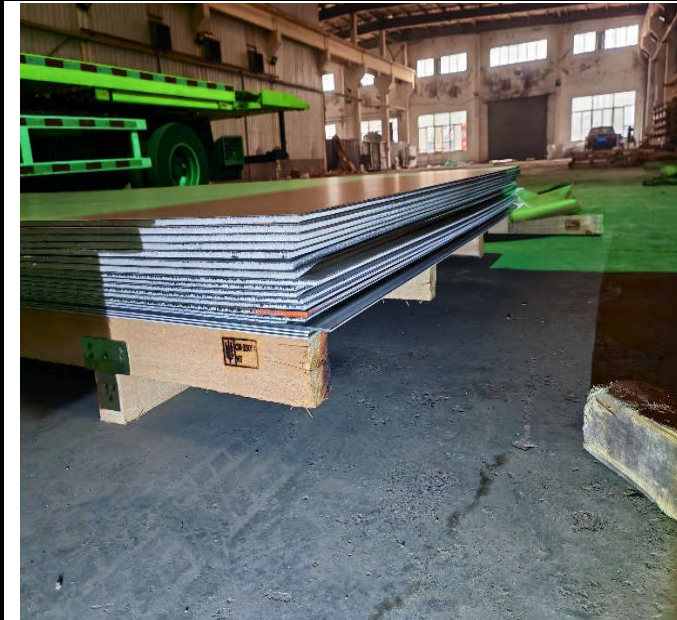
Visual and Marking inspection

- The mark is print on the steel plate and is composed of manufacturer + material grade + dimension +heat no, for example “TOLE EN ACIER INOXYDABLE 310S 3000mmX1500mmX10mm”comply with the requirements;

- There is no marking for “ASTM A240 GR. 904L Stainless steel perforated plate 3000X1500X6mm, RD10mm” plate, the result is pending;

- There is only one set mark on each plate it is not comply with ASTM 480/480M item 25.1.1.2 requirement.The result is pending.

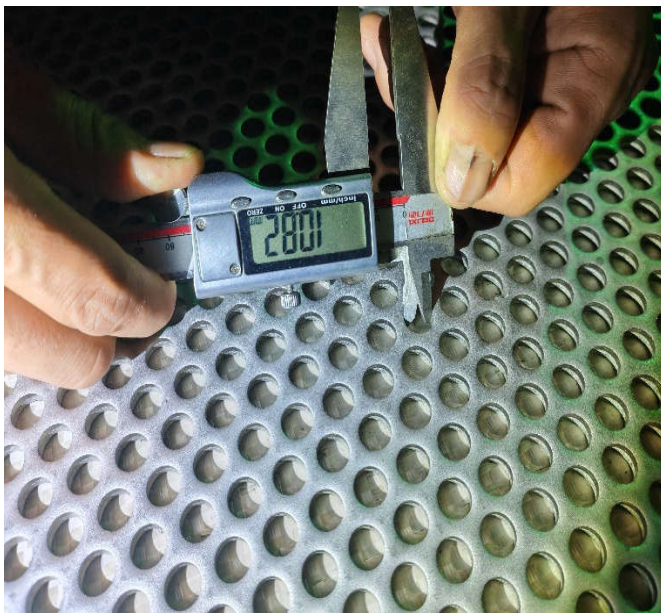
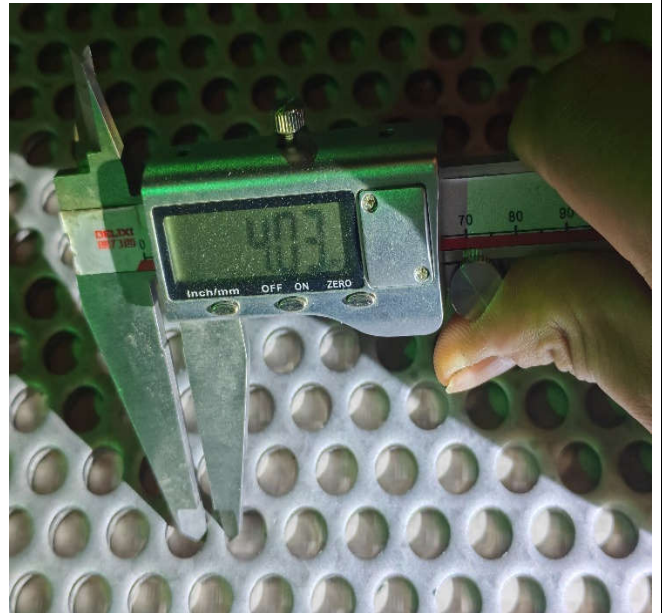
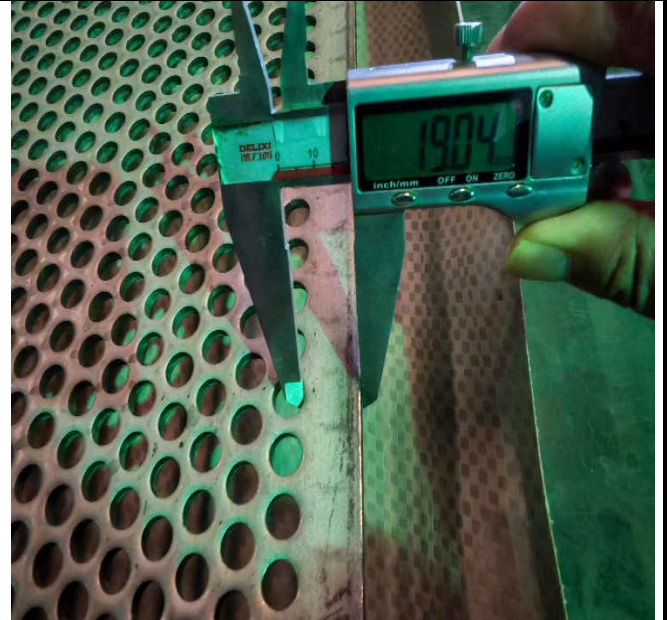
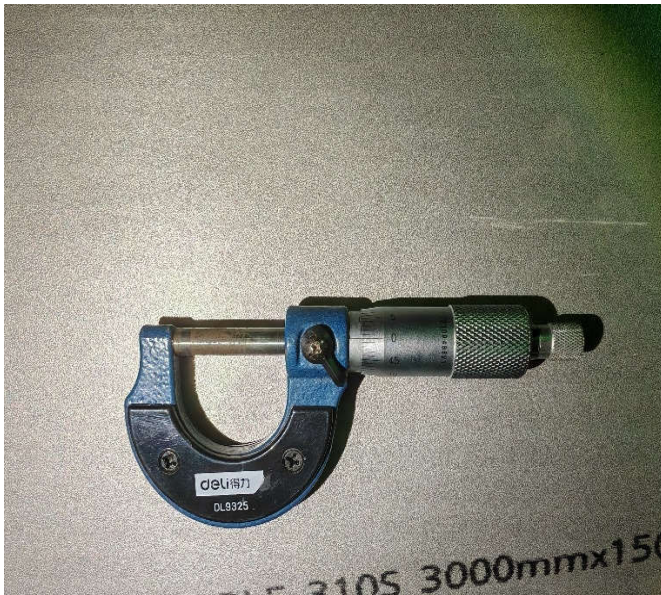
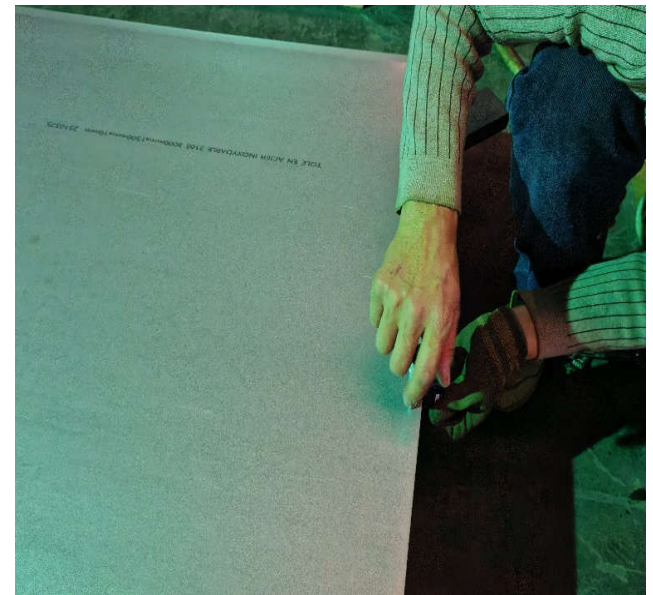
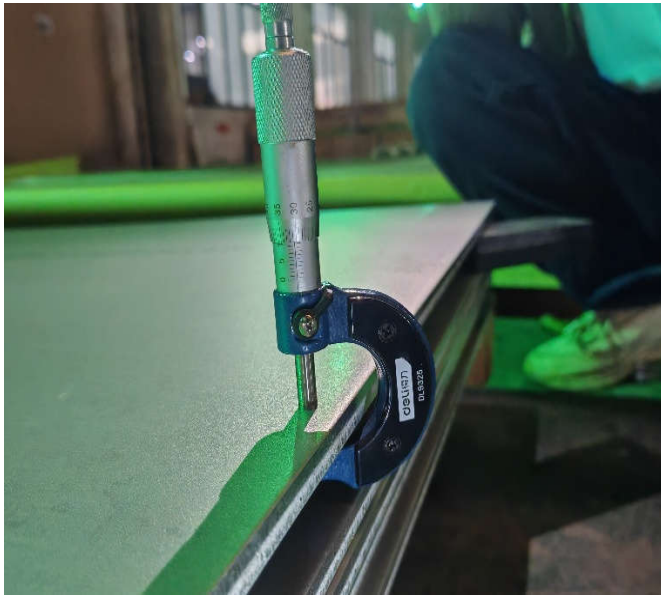
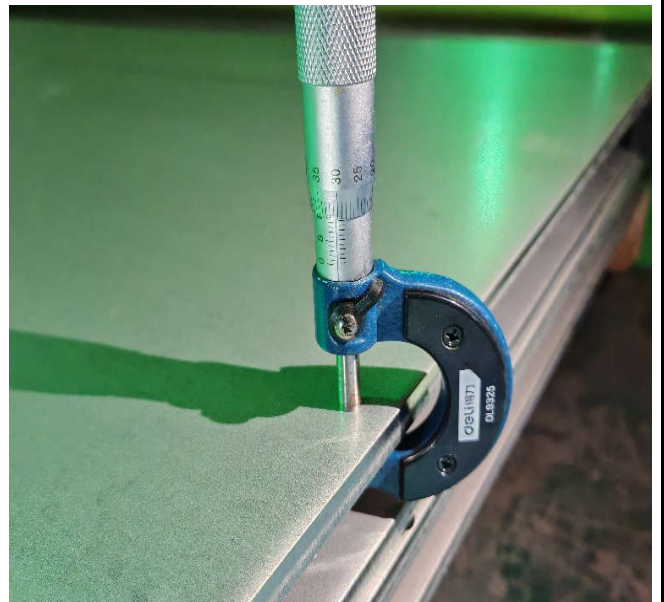
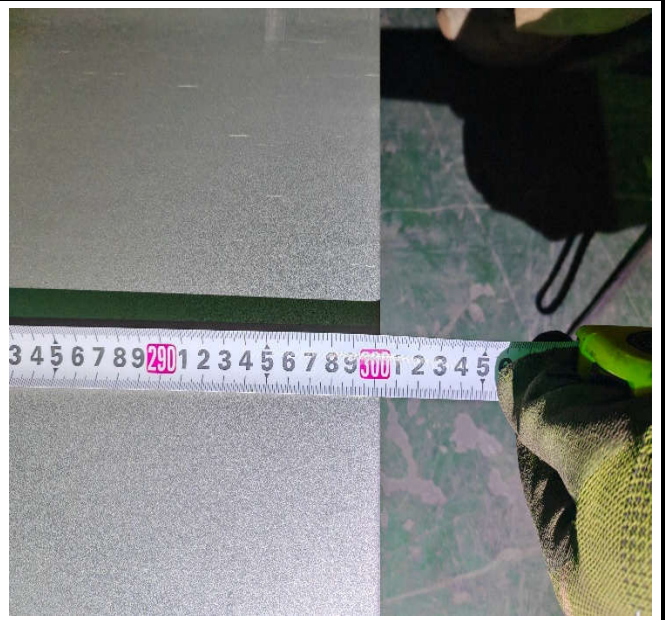
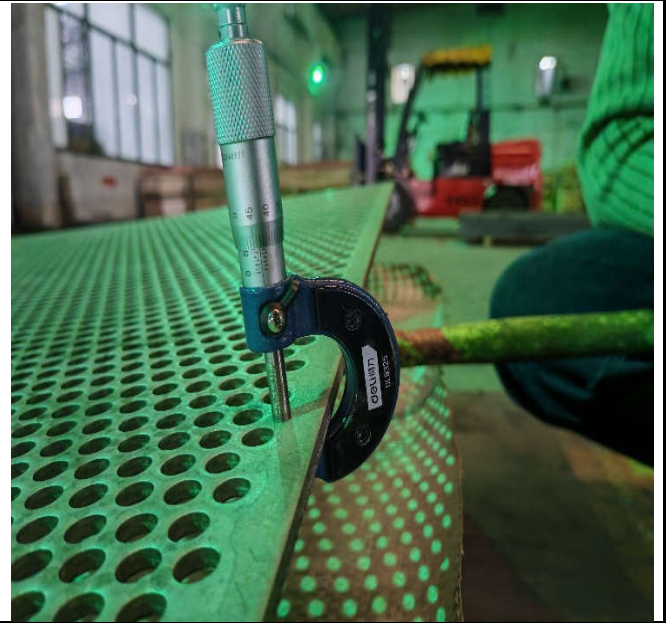
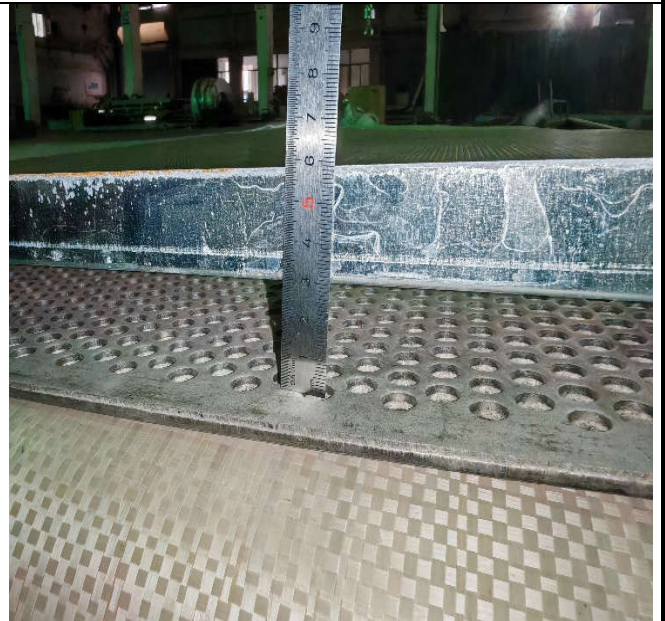
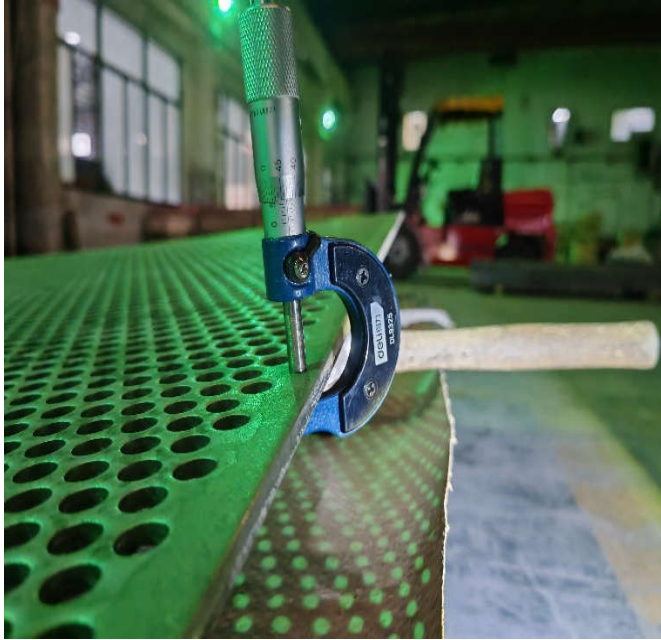
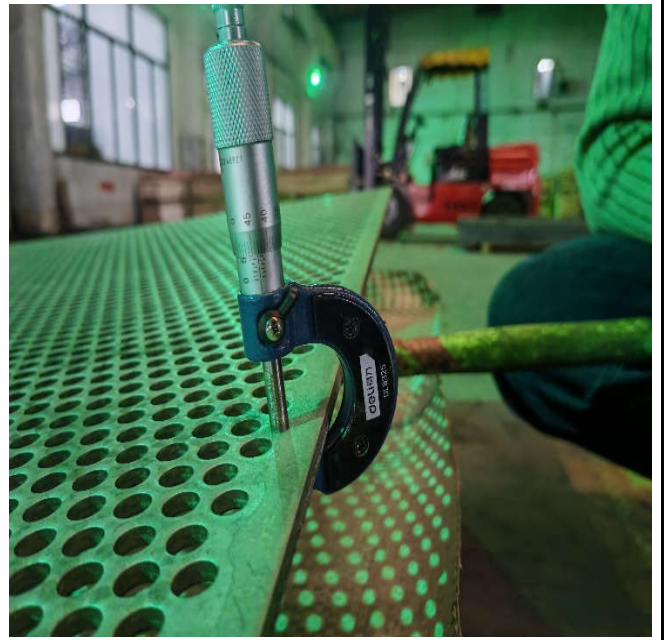
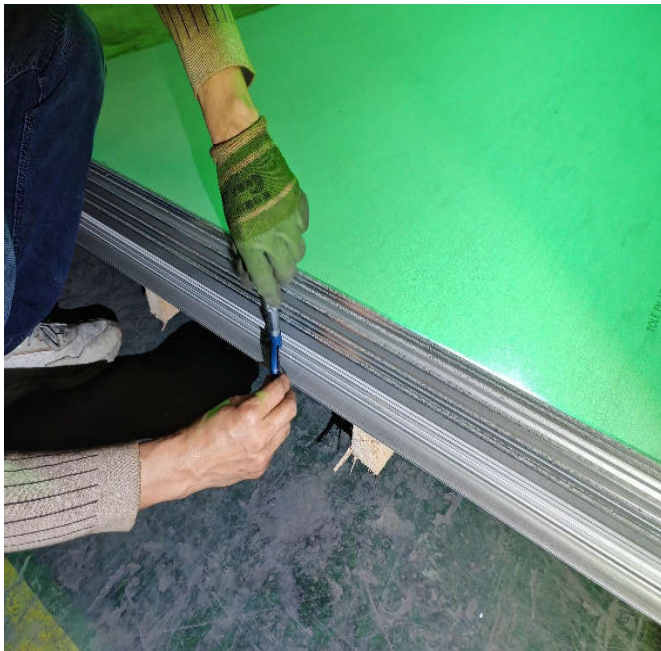
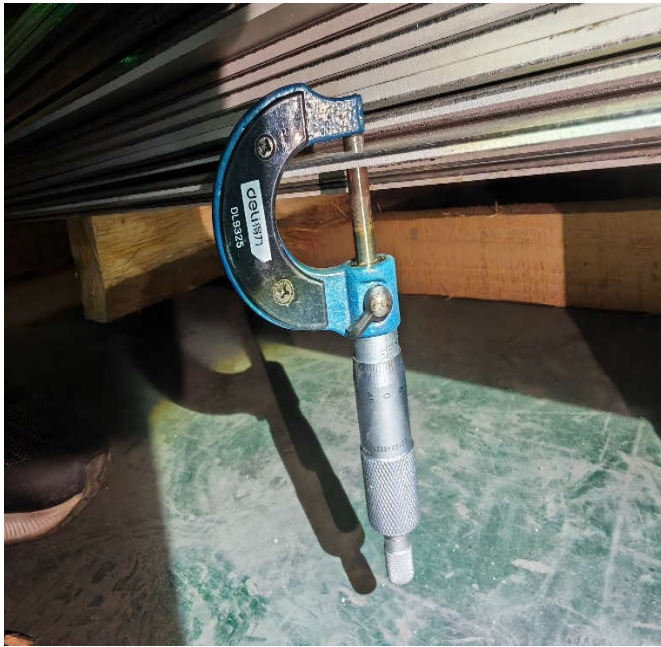
Dimension inspection

- The vendor stated that the steel plate has been stacked, and if moving each one around will scratch the surface of the steel plate, so they are no willing to performed one by one to the inspector for checking.
- The inspector witnessed dimension inspection of below items as many as possible, the measured dimension please refers below table:

- The actual flatness of “ASTM A240 GR. 904L Stainless steel perforated plate 3000X1500X6mm, RD10mm” plate (Max 23) was exceeding the standard requirement (30).
- The vendor did not provide the MTC for the inspector review;
- The vendor did not provide the calibration certificate for the inspector review.

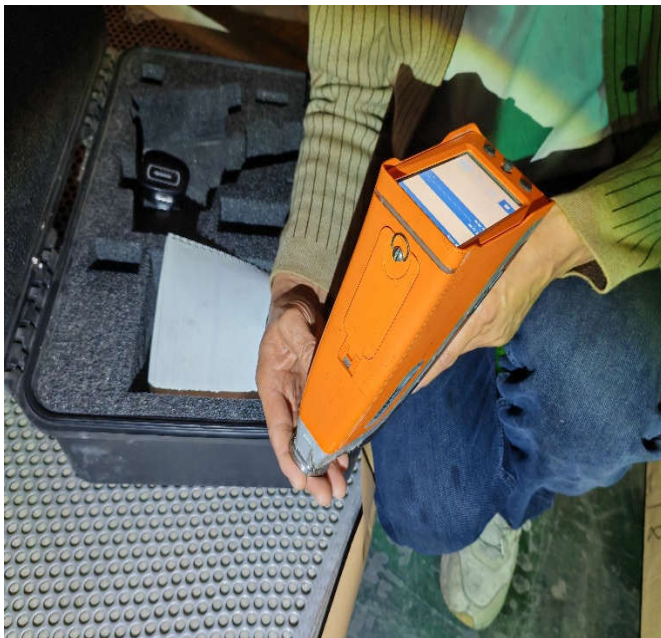
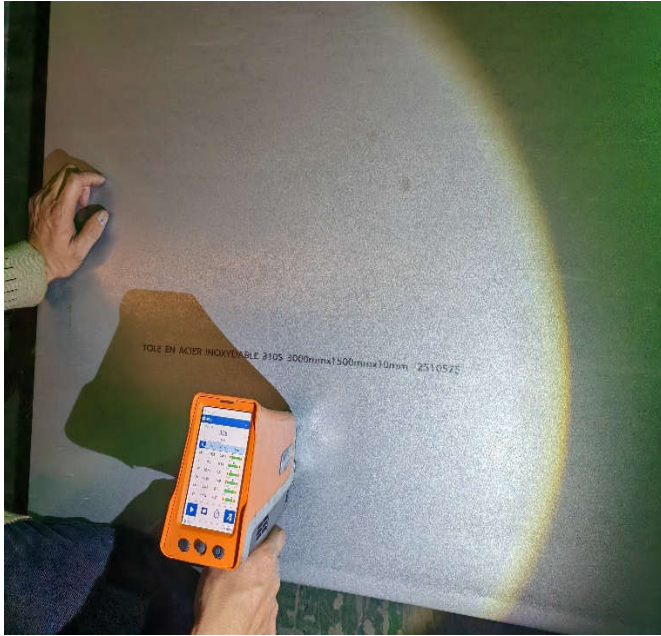
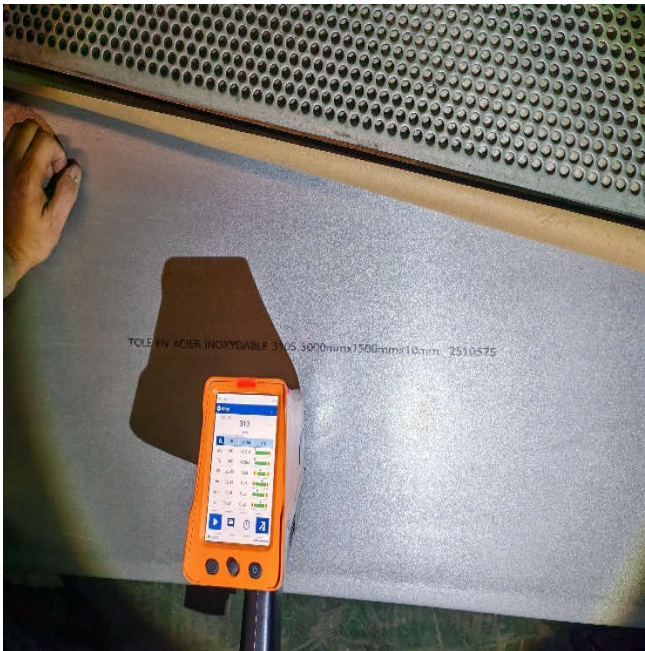
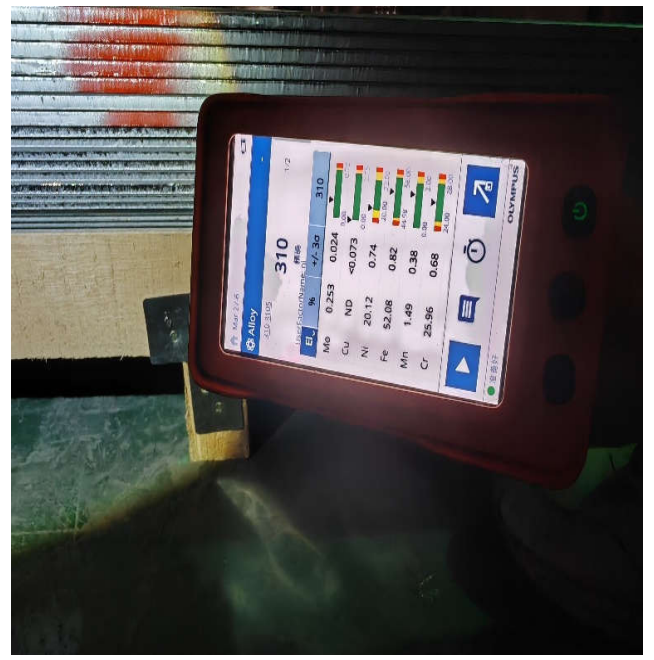
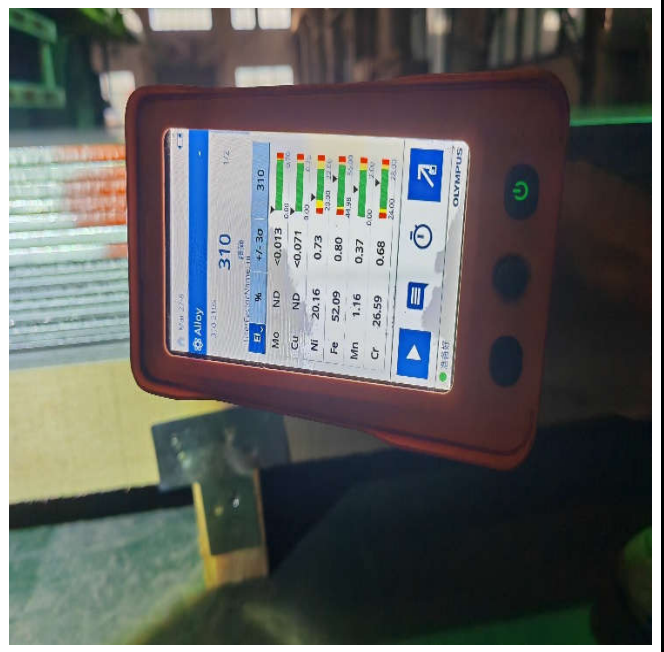
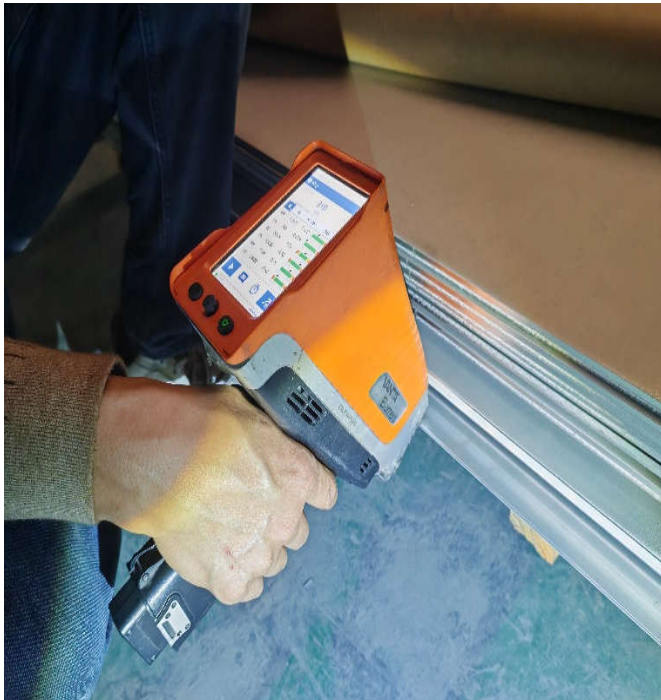
PMI

Alloy			
316 316L			
316			
制造商/品牌			
El.	%	+/- 3σ	316
Mo	2.068	0.066	合格
Cu	0.41	0.14	合格
Ni	10.82	0.55	合格
Fe	67.84	0.69	合格
Mn	1.03	0.32	合格
Cr	17.74	0.52	合格

- Due to the vendor use the portable spectrometer to identify the material grade, normally the content of the chemical component to be tested is within the range of $\pm 10\%$ of the standard value, which could be acceptable.
