REPORT No. : INPREPORT202512130020

Inspection Report

InspectionProject: SIZE/PMI/PICKING
检验项目

**Client: HEBEI ABTER STEEL
PIPE CO., LTD**

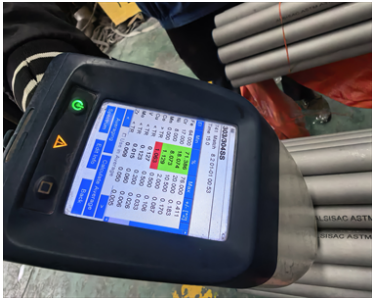
| PO.1 item | PO.2 item | PO.3 item |

We further tested the pipe fitting materials: the PMI test required by was qualified

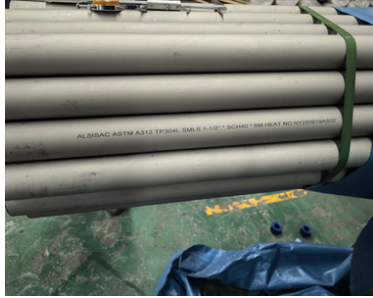
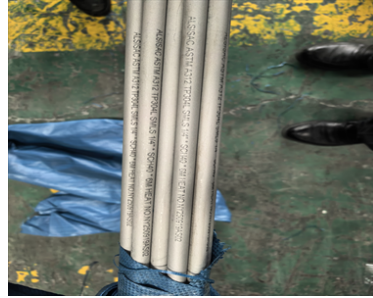
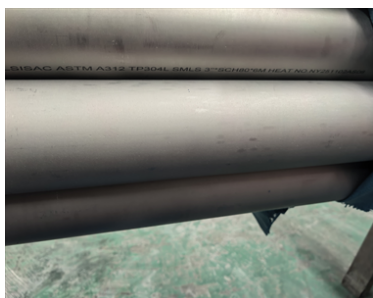
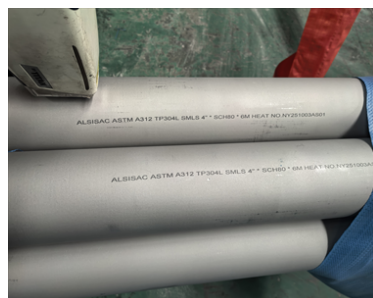
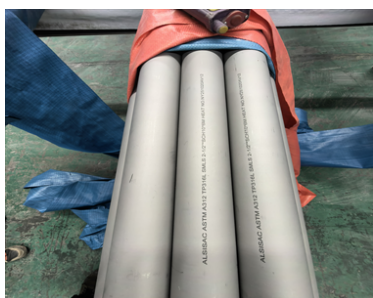
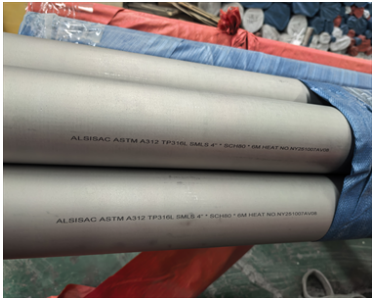
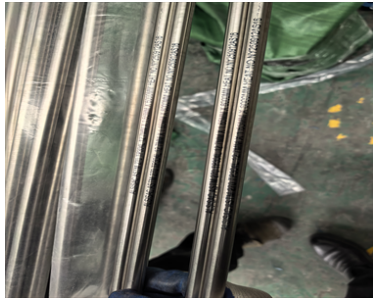
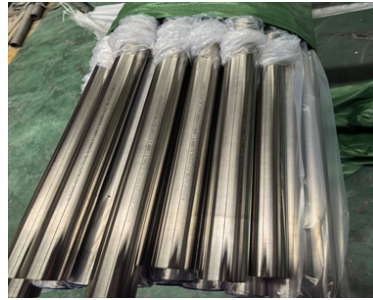
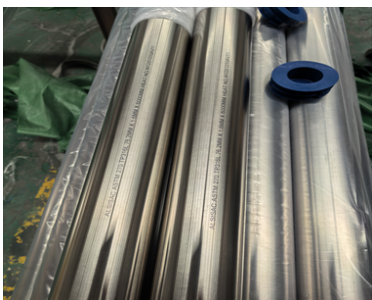
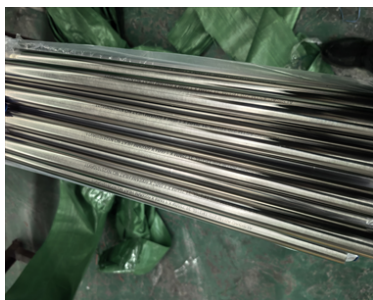
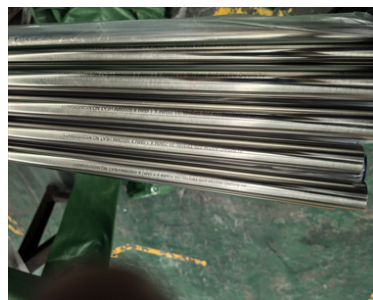
5.ProductMarkingPhoto

Inspectors inspected the appearance and identification and found no defects beyond the standard. The identification name, product name standard and material grade, specification/heat number are traceable and comply with relevant standards and customer requirements. See photos for identification details. The appearance and identification inspection results are qualified.

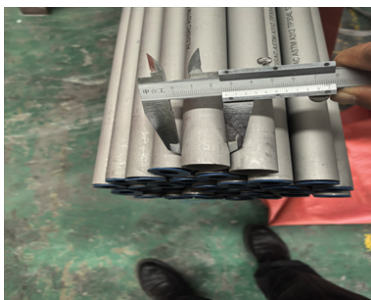
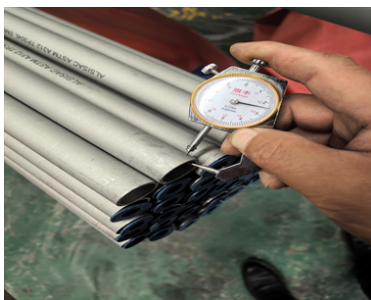
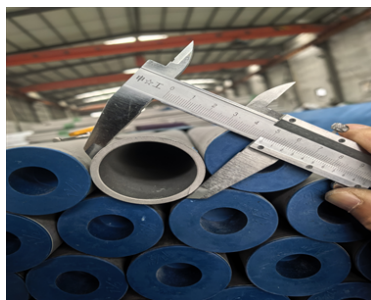
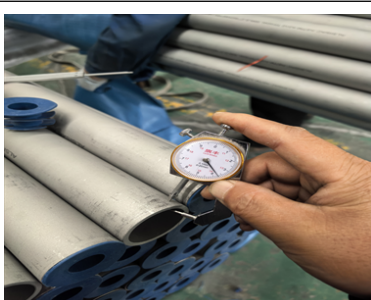
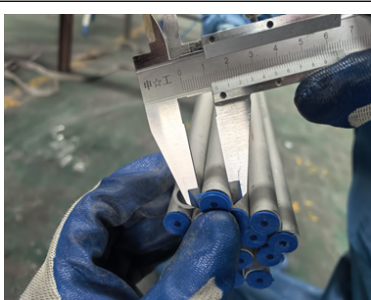
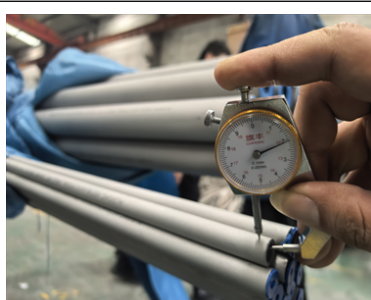
6. Dimensional inspection photo

Major dimensions (outside diameter/length/bevel/thickness) checked, measured and witnessed by factory personnellInspector, no dimension found in standard ASTM A312,ASTM A270 , acceptable.
