INSPECTION REPORT

Project	Pipe Inspection	Notification No.	N/A
Report No.	CIK-IR-Cangzhou-Abert-Pipe-20251221-22	PO No.	N/A

Vendor/Location	HEBEI ABTER STEEL PIPE CO., LTD	Person Contracted	Mr. Huang
Sub-vendor/Loc.	Cangzhou City, Hebei Province, China	Inspection Date	Dec. 21 st & 22 nd 2025
Delivery Date	N/A	Next Inspection Date	N/A

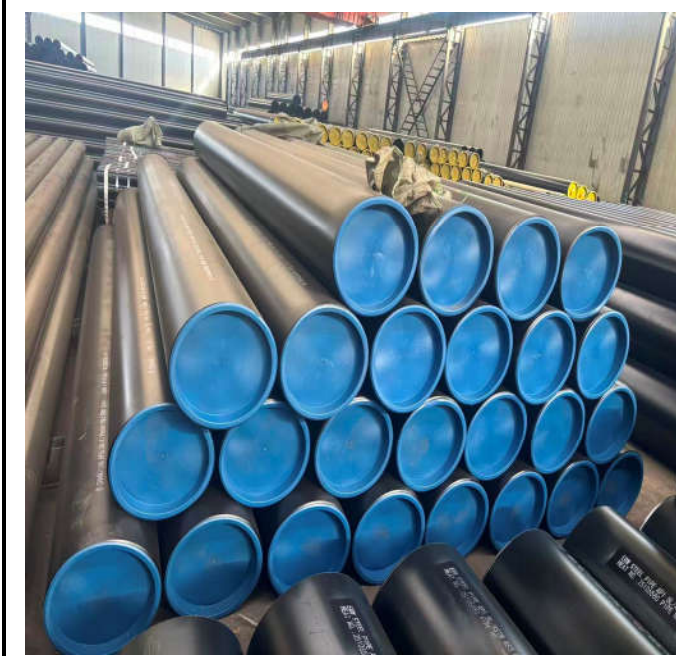
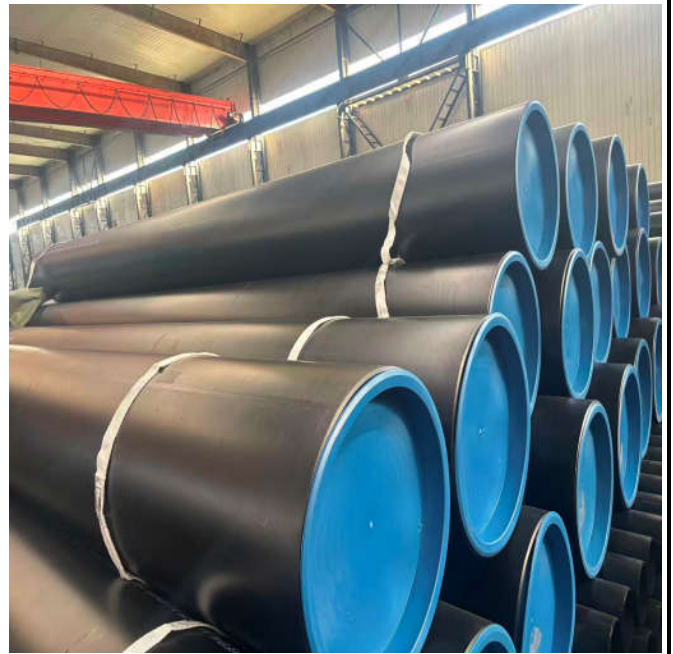
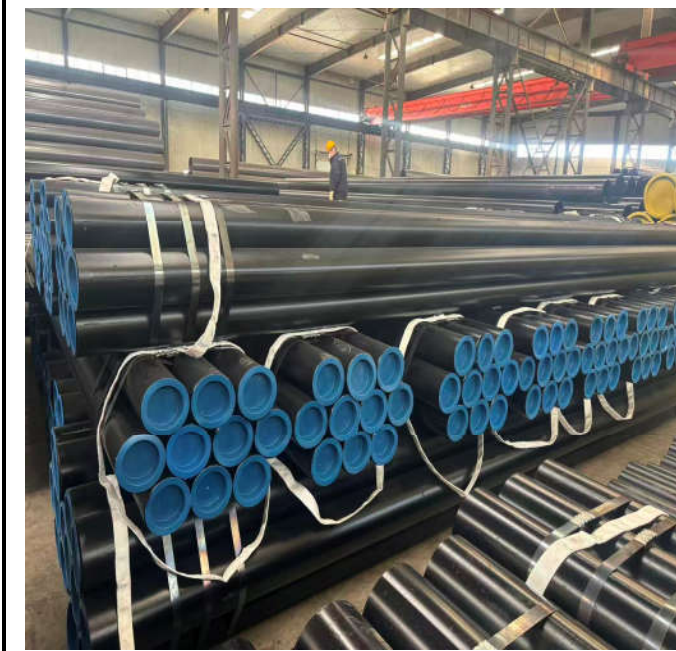
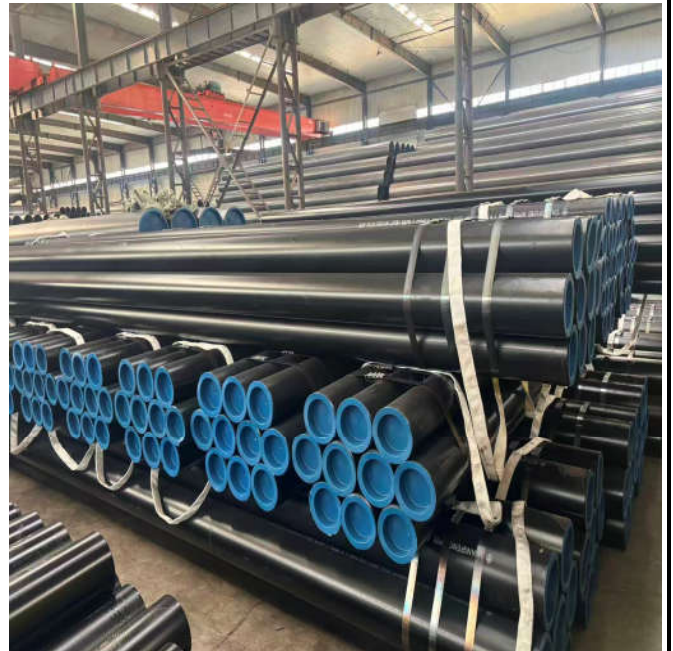
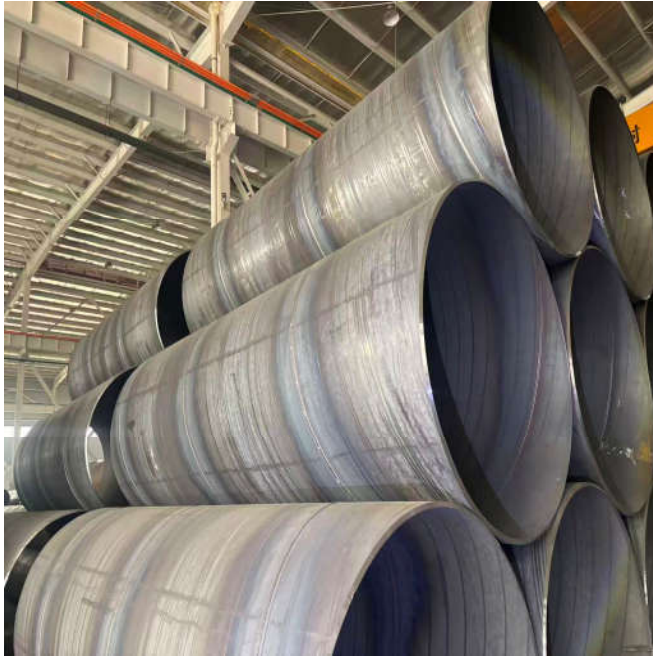
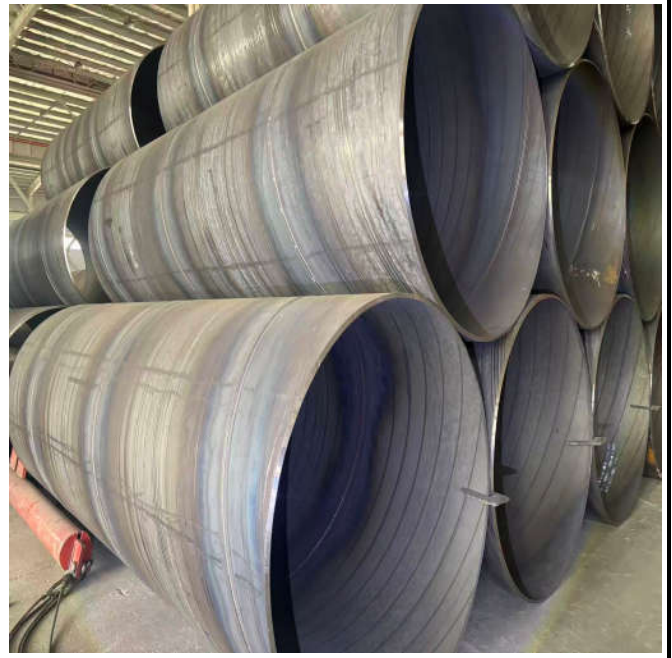
- According to the check list, the inspector performed quantity check for the SMLS, ERW, SAWsteel pipe for each specification.
 - The actual quantity was consistent with the inspection list quantity.

Quantity inspection

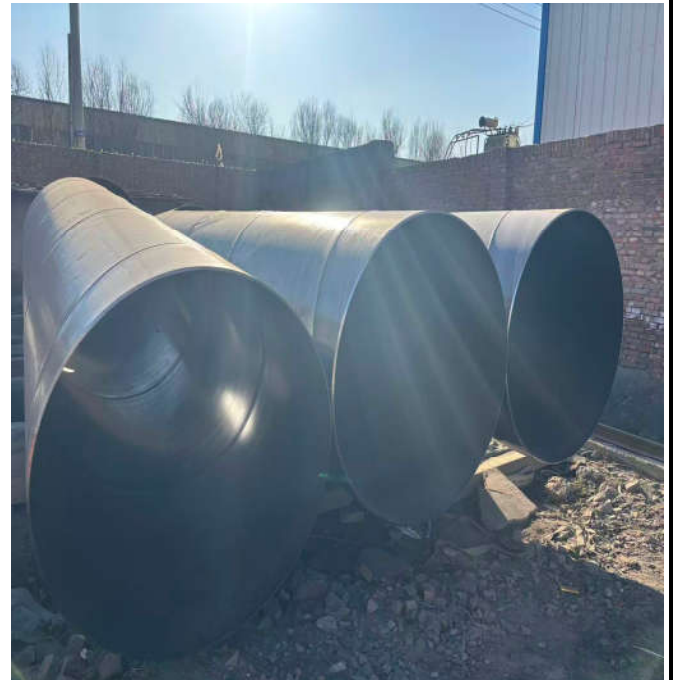
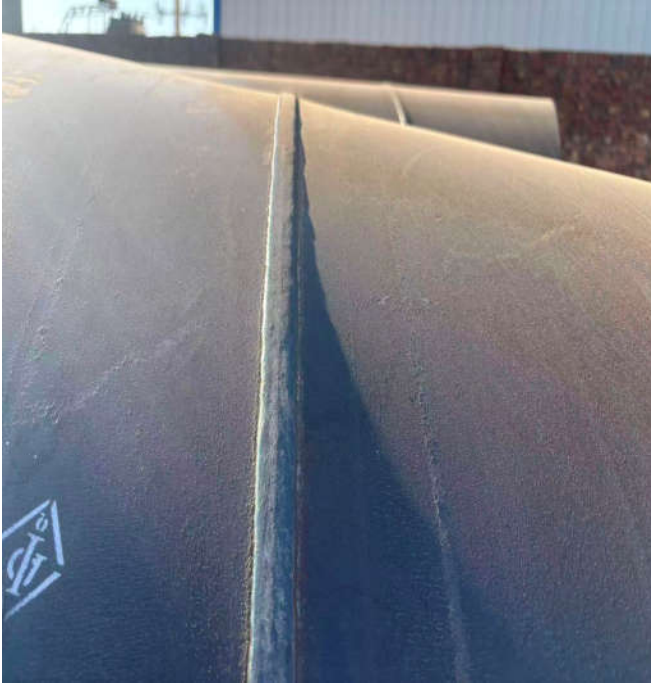
- The pipe outer and inner surface was smooth, no defect found, such as crack, scratch, porosity, pit etc.
 - The inspection result was acceptable with the below comment.

Visual inspection

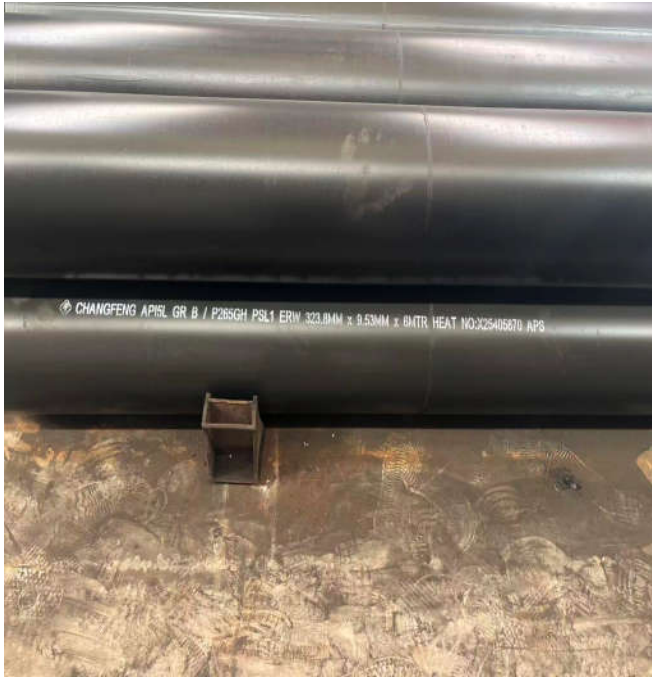
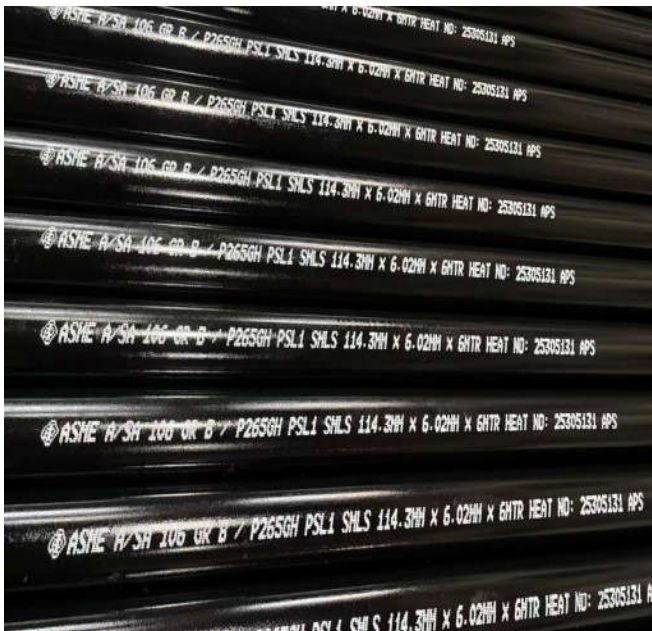
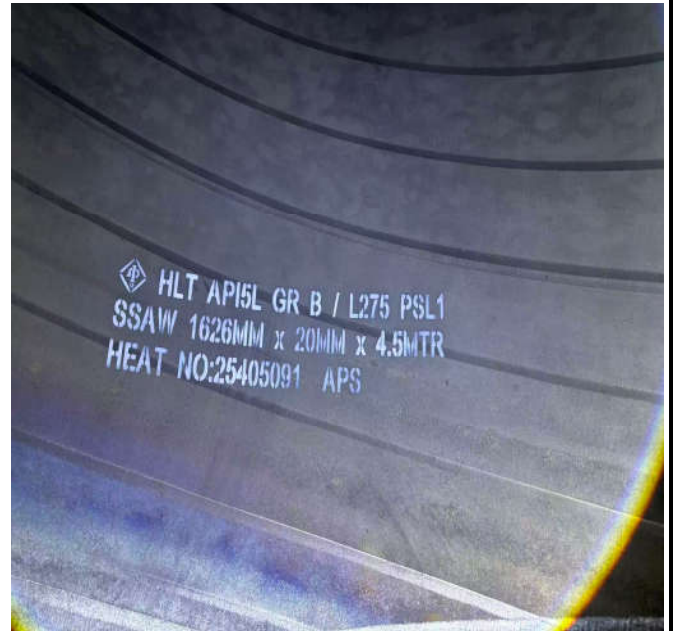
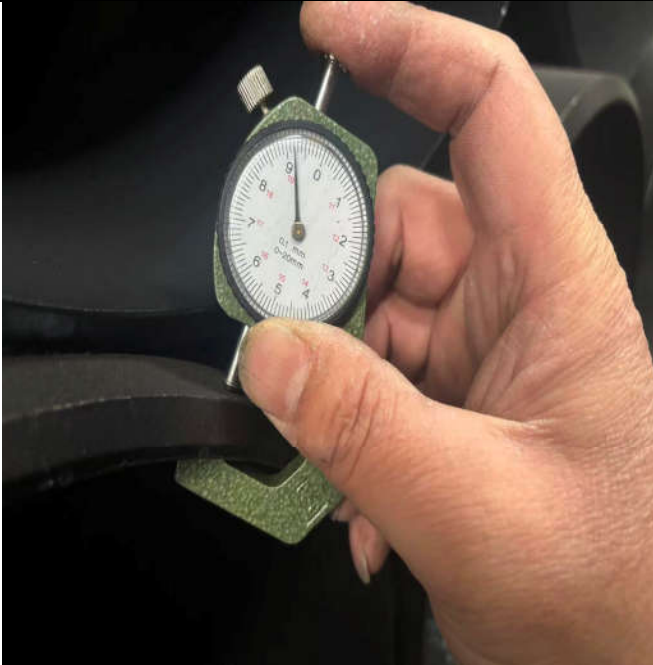
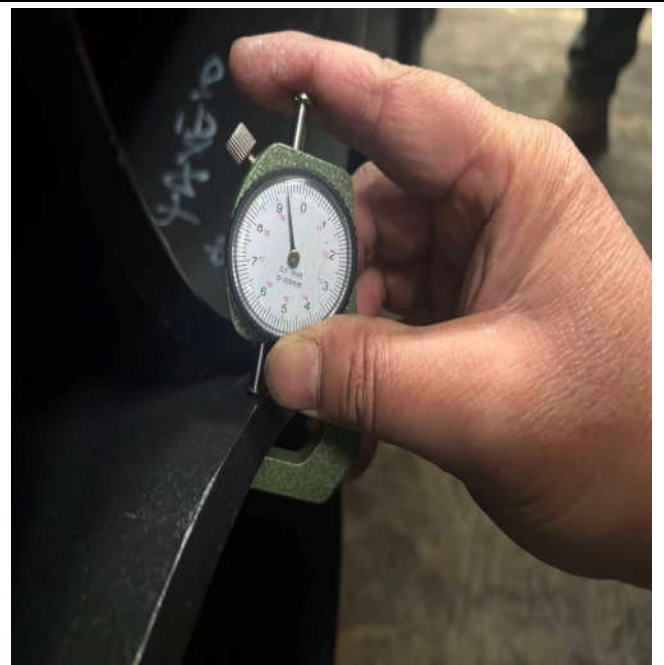
- As the request of client's instruction, CIK inspector performed marking inspection for SMLSsteel pipe, the steel pipe marking by paint spray on the pipe body,
- The result was acceptable.
- Detail identification as follow:

Marking inspection

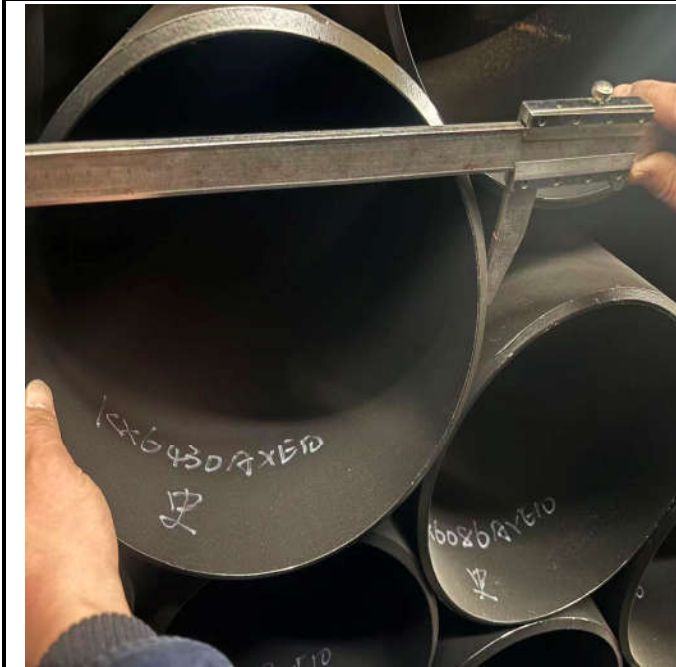
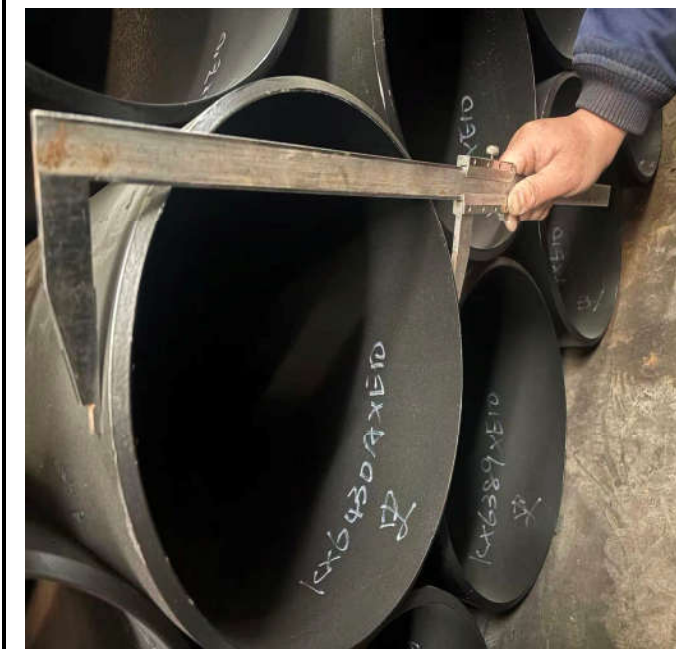
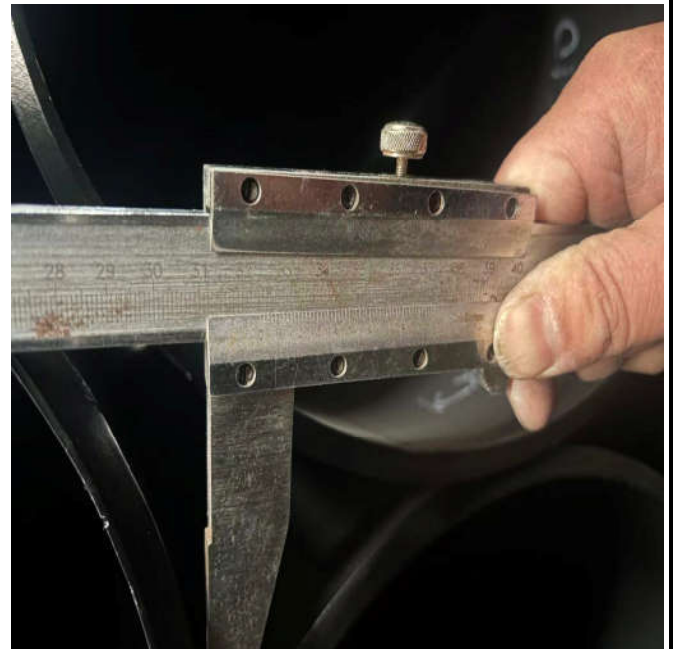
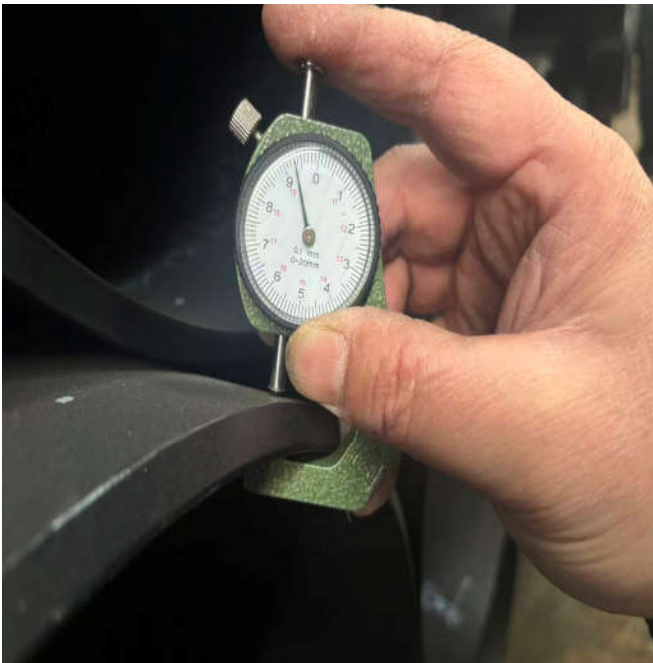
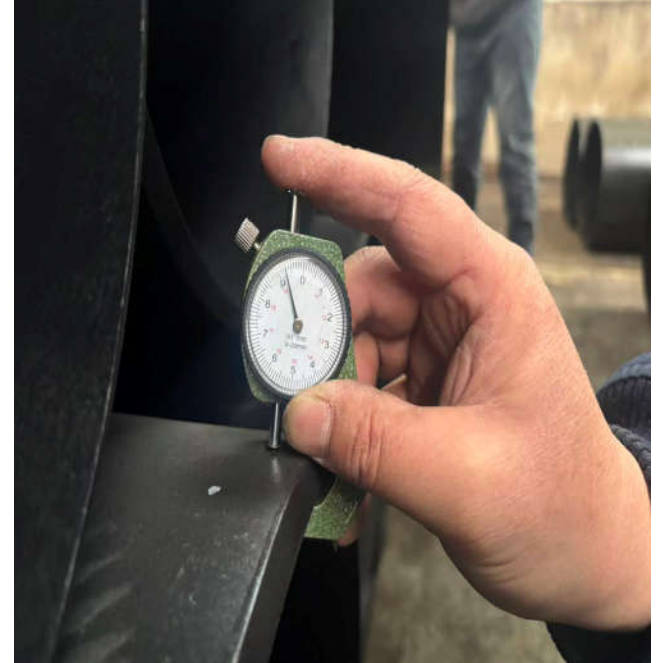
- Before dimension inspection, all used tools were checked and found in good condition and calibrated.
- The dimension inspection result was acceptable with comment.
- Details as below:

Dimension inspection

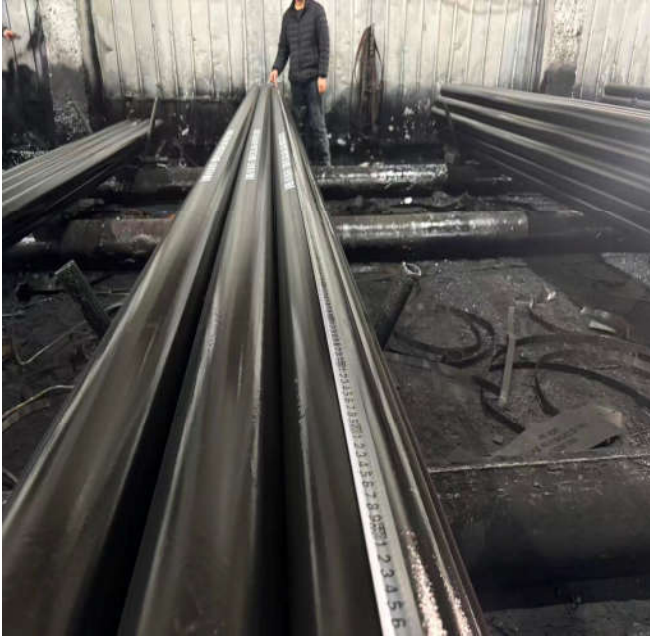
Some iron filings and debris

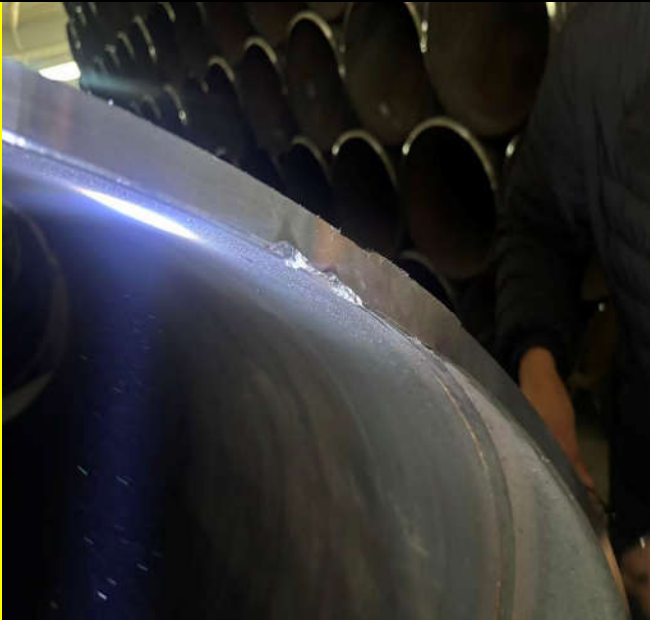
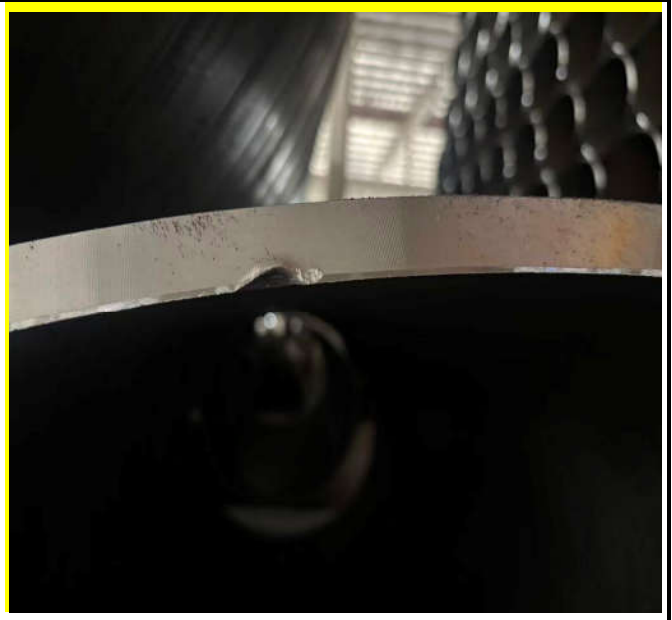
- Comment-01: Some damage was found on item 1 pipe bevel surface.
 - **Dimensional check at rate 5%**
 - CIK inspector performed the dimensional check for the SMLS, ERW, SAWsteel pipe for each specification.

Bevel damage

- Comment-01: Some damage was found on item 1 pipe bevel surface.
- Comment-02: For the item1, the API 5L standard did not specify OD's>1422mm diameter tolerance, needs to be confirmed by client.
- Comment-03: Due to the measuring tool being limited, so the weld seam height could not be checked.
- Comment-04: The factory did not provide any documents for the inspector to review.
